HISTORIC STRUCTURE REPORT
FLUVANNA COUNTY HISTORIC COURTHOUSE
COUNTY OF FLUVANNA, VIRGINIA

HISTORIC STRUCTURE REPORT

FINAL REPORT

September 7, 2022

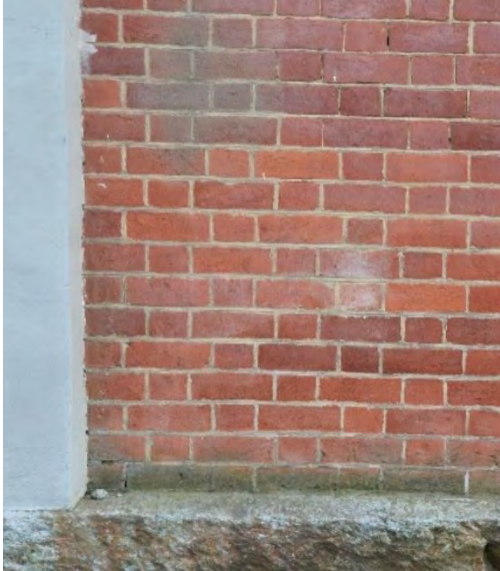
MB.9

<p>Existing exterior surfaces display soiling in localized areas.</p> <p>Clean localized staining from exterior walls. Preferred cleaning approach is hand-washing with mild detergent with care to be taken at mortar joints to minimize damage and erosion. A low-pressure water wash of less than 400 psi may be utilized in lieu of hand washing after testing a small area to determine impact to historic materials.</p>	250 SF
MB.10

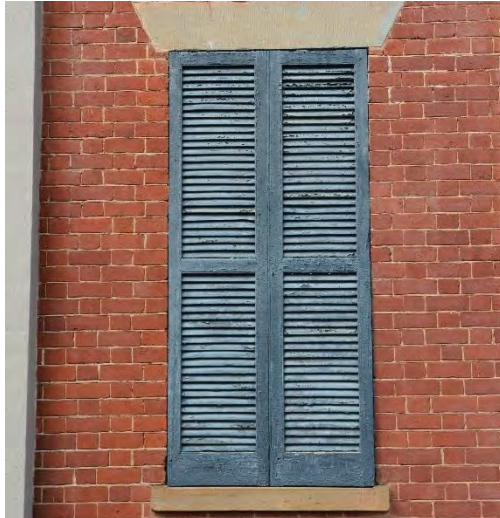
<p>The masonry walls at the existing sham windows are hidden behind wood shutters and were not assessed.</p> <p>Remove wood shutters at sham windows and assess masonry walls. Perform work in concert with shutter restoration.</p>	3 locations
MB.11

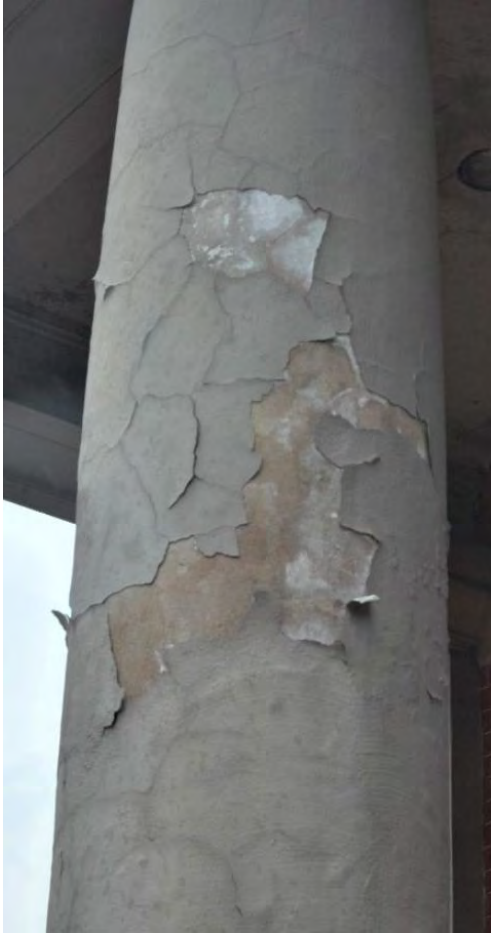
<p>Existing stucco surface at all columns and pilasters display extensive delamination of paint and finish stucco coat.</p> <p>Perform selective removal of stucco at columns to determine to confirm binder. Complete petrographic analysis to determine composition of stucco. This analysis will determine if a lime mortar was used. An inappropriate material such as Portland cement may have been used, leading to the finish issues. It may be necessary to remove the existing stucco from columns and pilasters to the brick substrate. If the composition of the stucco is appropriate, the issues may stem from application of the modern paint coating. To resolve this issue, remove paint and finish surface with breathable paint.</p>	<p>Small area of selective removals and petrographic analysis of existing stucco.</p> <p>Surface prep and repainting of all columns and pilasters.</p>

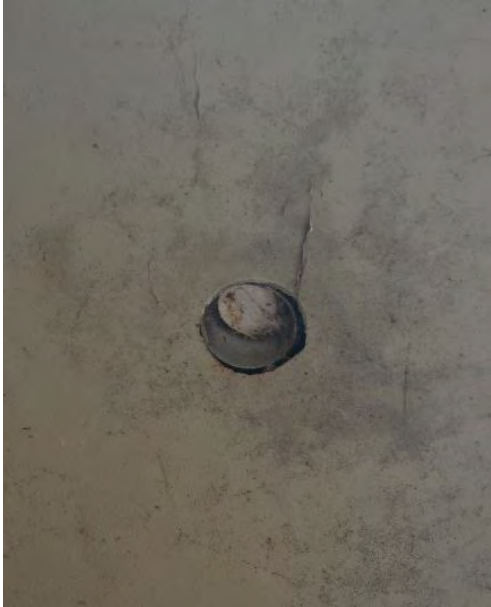
ST.2

<p>Existing portico stucco ceiling displays finish deterioration and localized areas of cracking.</p> <p>Gently sound damaged areas of stucco ceiling surfaces to determine extent of delamination. Remove loose or damaged areas of stucco.</p> <p>Prepare wood lath substrate to allow for sufficient bond with new stucco. Saturate wood lath with water in advance. Provide new stucco surface that matches composition and texture of existing stucco. Paint 100% of ceiling using breathable paint.</p>	<p>230 SF of repainting /</p> <p>20 SF of repair</p>

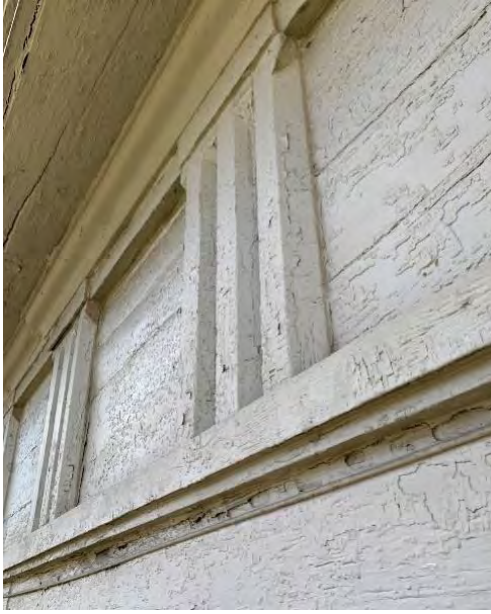
Existing wood cornice, pediment, and tympanum display varying degrees of failure of the existing painted finish. Since much of paint history was previously removed from these areas, scrape strip 100% of deteriorated paint finish. Assess wood substrate. Repair minor surface damage. Remove rotted elements and provide wood dutchman. Prepare wood surface for new sanded paint finish per original design. Repaint.	1,500 SF of repainting / 25 LF of repairs
WD.3

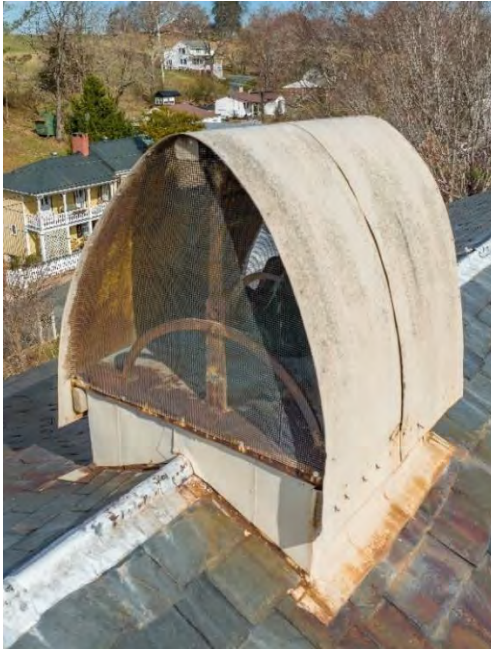
<p>The sheet metal bell enclosure displays corrosion and finish deterioration. The existing roof opening for the bell rope is allowing water to migrate into the building.</p> <p>Remove corroded sheet metal bell enclosure. Provide new enclosure. Determine design of new enclosure. Assess bell and mounting. Determine ability to reuse roof panels. Include attic vent and metal roof flashing at base of new enclosure. Provide flashing and sealant to create weatherproof opening for bell rope at horizontal metal surface.</p>	1 location (approx. 20 SF footprint)
MT.3

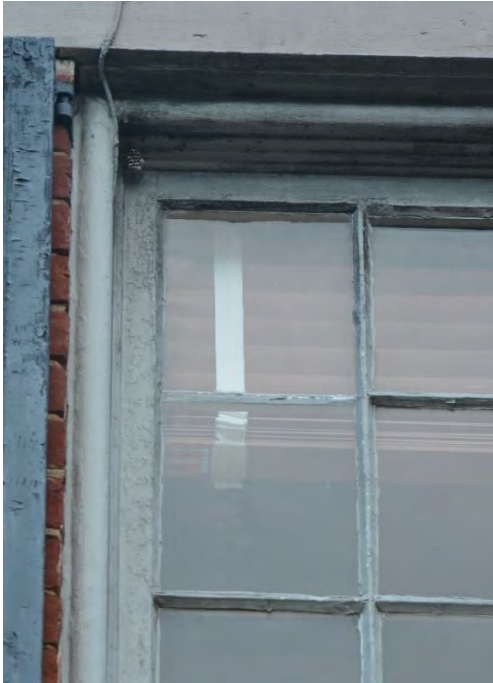
<p>Existing wood windows display finish and substrate deterioration at various components.</p> <p>Restore 100% of wood windows. Remove window sashes. Remove glazing putty and glass. Label and store glass for future reinstallation. Strip paint. Remove rotted wood from sash and frames. Remove perimeter sealant. Provide epoxy patch for all surface repairs and wood dutchman for rotted sections. Reglaze sash. Paint all sides of frame, sill, and sash. Reinstall sash. Provide perimeter sealant.</p>	<p>8 double-hung windows @ 25 SF each / 10 casement windows @ 15 SF each / 4 transoms @ 10 SF each</p>
W.2

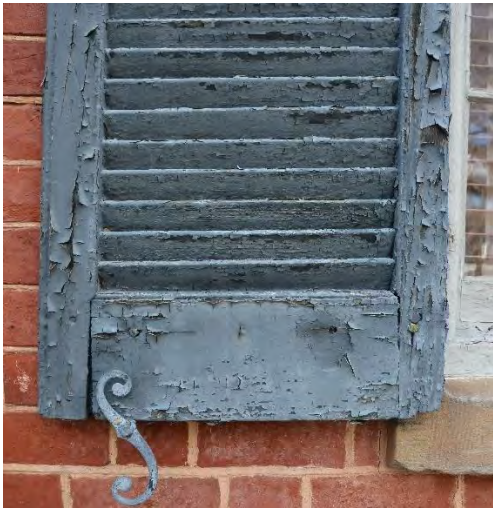
<p>Existing wood shutters display finish deterioration and apparent signs of wood rot.</p> <p>Restore wood shutters. Remove all painted wood shutters. Repair shutter hardware and secure any loose shutter dogs. Strip paint. Remove rotted wood. Provide epoxy patch for all surface repairs and wood dutchman for rotted elements. Paint all sides of shutters and hardware. Reinstall shutters.</p>	<p>10 locations @ 25 SF each, 10 locations @ 15 SF each</p>

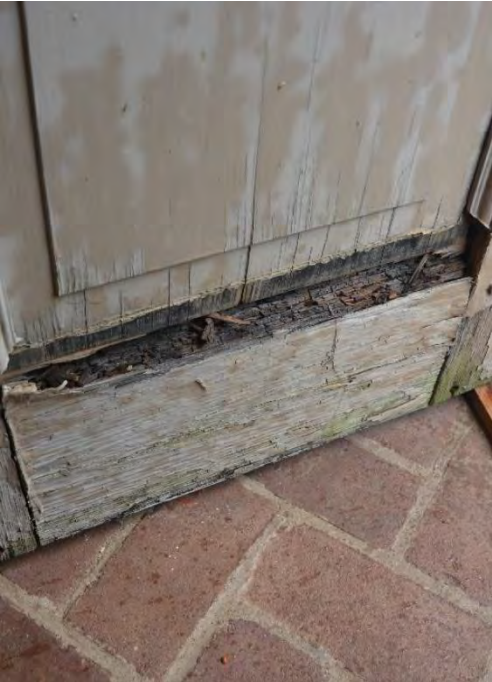
<p>Existing wood doors display finish and substrate deterioration at various elements.</p> <p>Restore wood doors. Remove wood doors. Repair door hardware to improve operability and latching. Remove deteriorated paint from door and frame. Remove rotted wood. Provide epoxy patch for all surface repairs and wood dutchman for rotted elements. Do not strip full surface of doors. Scrape and sand surface to prepare for new finish and paint all sides of door and frame. Reinstall door.</p>	<p>6 doors / Assume replacement of rotted bottom rail at 2 locations and 30 LF of wood door panel molding.</p>
D.2

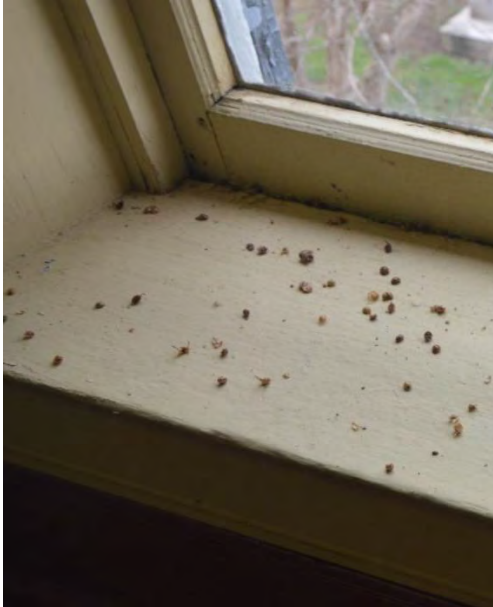
<p>There is a ladybug infestation in the second-floor jury rooms and a wasp infestation in the attic. Although not harmful to the building, it is recommended to remove these infestations.</p> <p>Address ladybug infestation via vacuum removal, installation of natural or chemical repellent, and/or traps. Perform removal after exterior repairs to prevent future reinfestation. Remove wasp nests from attic and fill openings with appropriate material to prevent additional infiltration.</p>	Upper floor and attic area

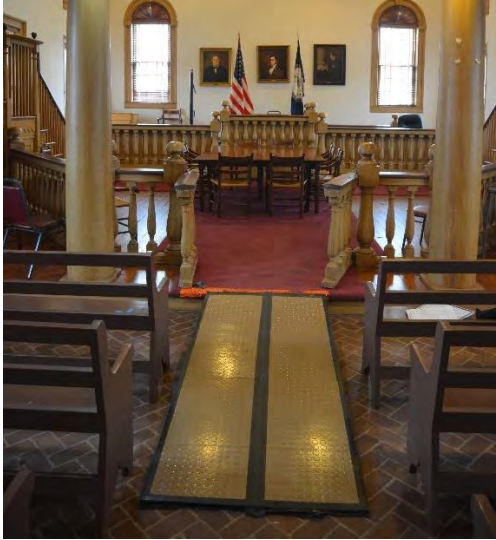
<p>Removeable ramp from brick floor to upper wood floor creates a tripping hazard at wood bench seating and lacks a raised edge or barrier along a raised edge to mitigate fall potential.</p> <p>Remove temporary ramp. Install fixed ramp with handrail at side wall of courtroom. Shorten benches to accommodate ramp location. Modify existing bar to install swinging gate to provide permanent accessible path.</p>	1 ramp @ 7 LF, modify three benches to shorten in length, install 3'-0" wide clear swing gate in existing bar

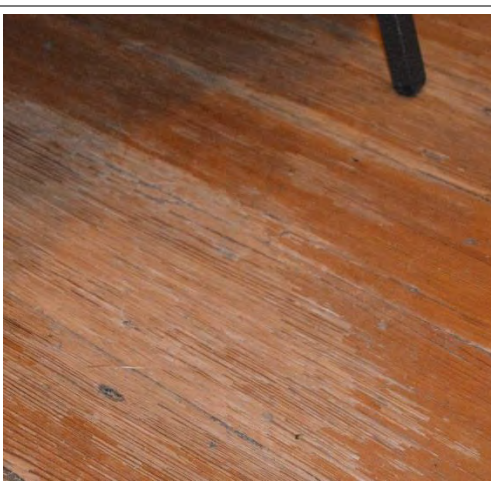
<p>Wood flooring has localized surface damage and gaps between floorboards.</p> <p>Repair and sand area of floor damage. Prepare surface for new flooring finish. Fill gaps measuring 1/4" or more with wood matching in species and graining. Provide new clear high-traffic coating on restored wood floor. Provide foot pads on all furniture.</p> <p>50 SF of damage / 1600 SF of refinishing</p>
F.8

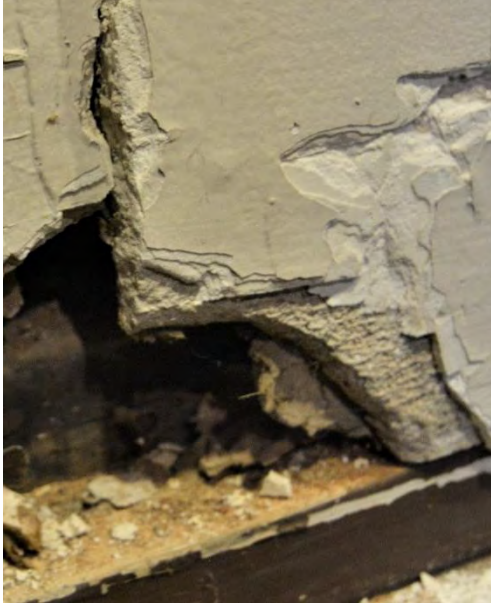
<p>Existing courtroom walls have a layer of plasterboard installed over the historic plaster finish. This alteration has negatively impacted the relationship of between the surface of the wall and the surface of the wood trim pieces.</p> <p>Selectively remove 5'-0" x 5'-0" area of deteriorated wall finish. Assess condition of plaster and masonry substrate. Determine impact of removal of interior wallboard finish on all courtroom walls to restore original design detailing.</p>	25 SF
WA.3

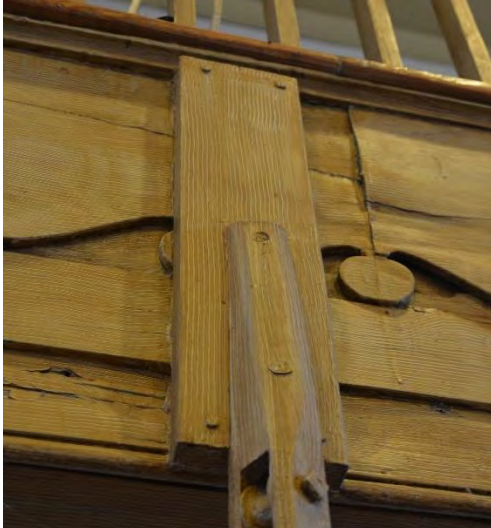
<p>Wood paneling at gallery beam is cracked and displays rot.</p> <p>Remove approximately 30" long portion of deteriorated wood paneling and pulley at gallery support beam. Remove wood paneling members in their entirety back to nearest joint. Do not cut wood to remove. Examine substrate to determine extent of damage. Remove any areas of wood rot and repair surface damage with epoxy. Reinstall paneling. Paint.</p>	5 SF

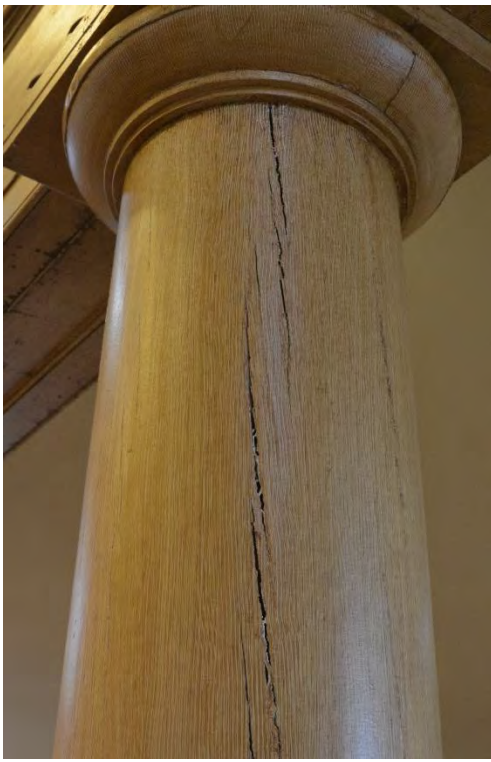
Wood columns have checks, or cracks, along full height. Wide gaps are present where filler previously installed in checks has failed.	25 LF
		Monitor columns throughout year. Determine if repair is desired per findings. Remove sealant fill at checks in hollow bored wood columns. Fill checks. For narrow checks (less than 1/8") use epoxy paste filler. For checks larger than 1/8," install a narrow, tapered slat of pine into crack during dry season. Apply adhesive and drive slat into the check with light taps from hammer. Once glue dries, trim excess glue and slat. Repaint column.	
WA.11

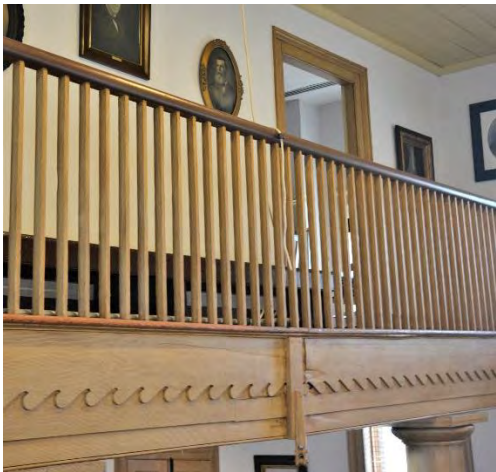
Wood balustrade at upper gallery flexes under light pressure and does not meet current code requirements for structural integrity Depending upon level of alteration in future restoration efforts, the handrail may need to be reinforced. If reinforcement is required, design improvements to minimize visual intrusion.	1 location of 25 LF
OI.3

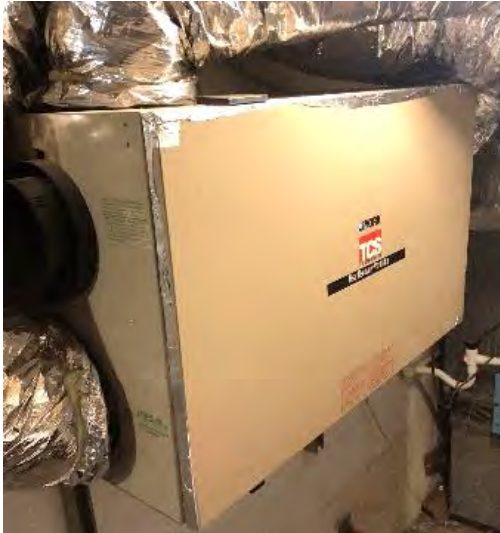
<p>Heat recovery ventilator (HRV) in the mechanical room is no longer operational.</p> <p>Replace defunct HRV with a new energy recovery unit (ERU) to provide exhaust and pre-conditioned room temperature-and-humidity neutral outside air to the occupied spaces. Provide automatic digital controls to insure the new ERU operates when occupants are present. Estimated capacity of 300 CFM.</p>	<p>1 ERU</p>
M.7	 	<p>Basement bathroom exhaust fans are aged.</p> <p>Replace bathroom exhaust fan/lights in 1 existing operating bathroom. Determine potential for unused bathrooms to return to active use. If so, replace fans.</p>	<p>1 bathroom exhaust fan</p>
