HISTORIC STRUCTURE REPORT
FLUVANNA COUNTY HISTORIC COURTHOUSE
COUNTY OF FLUVANNA, VIRGINIA

HISTORIC STRUCTURE REPORT

FINAL REPORT

September 7, 2022

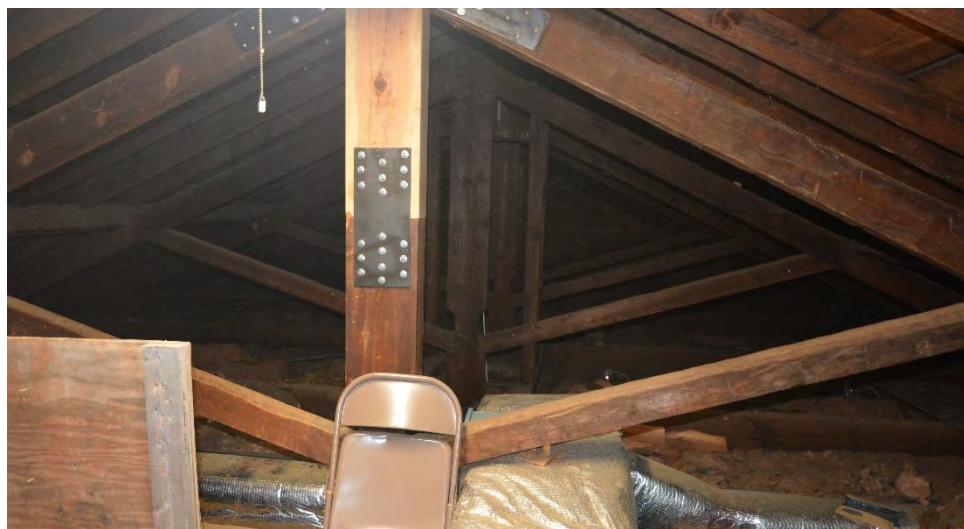
Figure 57. View of roof structure with repaired truss in foreground

- The primary area of concern occurs at the chimney penetration locations through the roof. At three of the four chimney penetrations, the rafters flanking the chimney have rotted to the extent that the ends of the rafters are no longer supported on the adjacent exterior wall. Additionally, the mortar in the chimney has severely deteriorated and is in need of full depth repointing.
- The second area of concern occurs at the cupola. Water has penetrated through the roof and traveled down the bell enclosure structure to where it has rotted the support structure at the attic level. The connection of the bell enclosure support post to the adjacent roof structure has also rotted. The most structurally significant damage has occurred where the top half of the bottom chord of one of the trusses has rotted where it supports the bell enclosure beam.

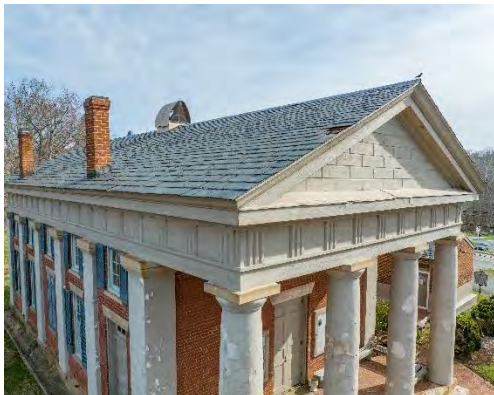
<p>The building does not currently have lightning protection and was recently damaged by an apparent lightning strike.</p> <p>Provide lightning protection system to mitigate potential for future damage.</p>	Full building lighting protection system

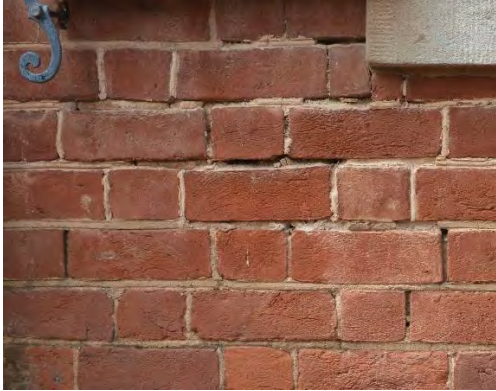
CODE	PHOTOGRAPH	CONDITION/REPAIR	QUANTITY
MB.1

<p>Open mortar joints and mortar deterioration occur on all elevations.</p> <p>Repoint open brick masonry joints with recommended mortar mixture using techniques to match original mortar joints. See further discussion in Key Issues section.</p>	125 SF
MB.2

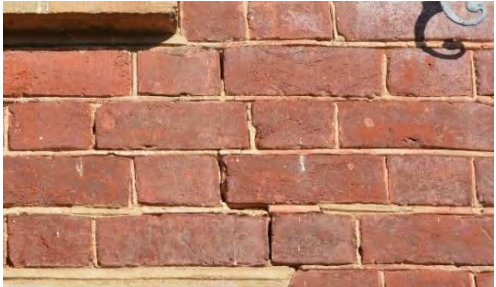
<p>Stairstep cracks occur in the mortar joints extending from the heads of many windows and door openings.</p> <p>Repoint localized areas identified on drawings, refer to MB.1 for repair and quantity.</p>	See MB.1
MB.3

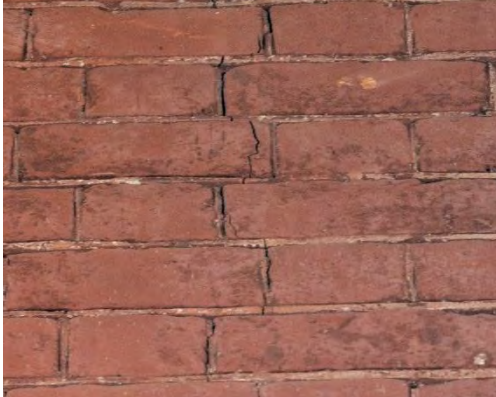
<p>Brick masonry units are cracked in several locations. This issue occurs with greatest frequency at the window lintel bearing points and near the south doors.</p> <p>Remove cracked brick unit. Provide matching brick unit and install in concert with wall repointing.</p>	8 brick units
MB.4

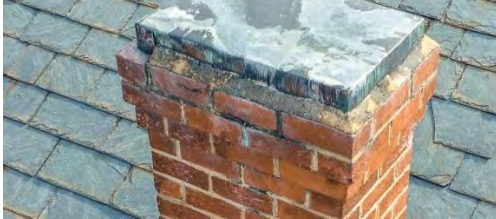
<p>Existing brick unit appears to be displaced from masonry assembly.</p> <p>Remove and reset displaced brick unit.</p>	1 brick unit

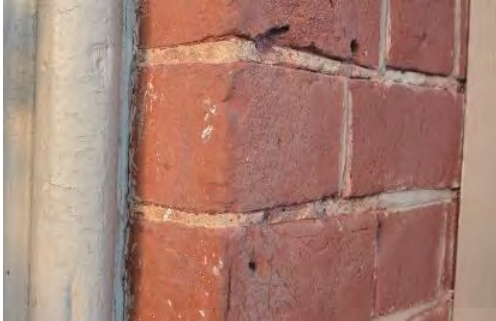
<p>There are holes in the brick masonry, apparently made by anchors in a small number of locations.</p> <p>Repair holes in masonry wall with compatible color-matched patching mortar.</p>	3 locations
MB.7	 	<p>Deteriorated paint from an adjacent painted surface has stained the masonry walls.</p> <p>Remove paint staining from surface of masonry walls. Perform tests on masonry and pursue the gentlest effective method.</p>	80 SF
MB.8	 	<p>Overpaint is present on masonry surfaces directly adjacent to painted surfaces.</p> <p>Remove overpaint on brick surfaces using the gentlest effective method.</p>	160 LF

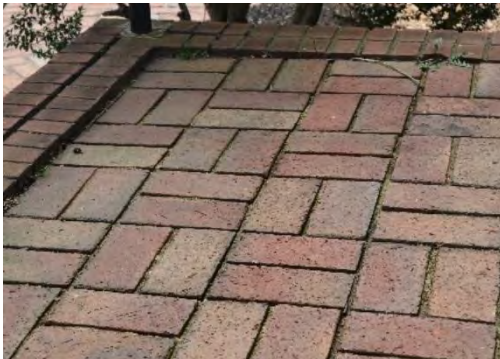
<p>Existing brick paved walking surface at accessible ramp on east side of the building displays signs of settlement and open mortar joints.</p> <p>Remove brick pavers and reset at landing to resolve settling. Repoint 100% of brick walking surface and ramp walls.</p>	120 SF

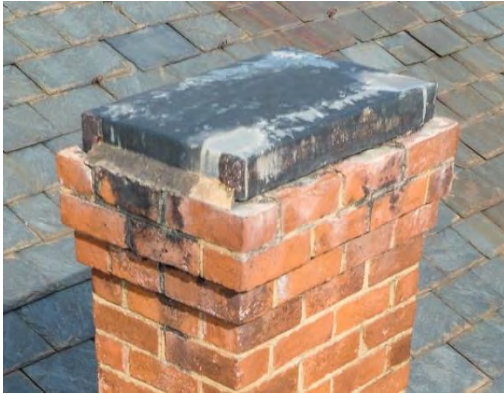
MB.12

<p>At top of existing chimney, the sloping mortar cap abuts the copper flue cap. This condition has led to deterioration of mortar.</p> <p>Remove chimney cap. Provide new copper chimney cap to cover, rather than abut, a new sloping mortar cap at top corbel.</p>	4 locations @ 8 LF each
MS.1

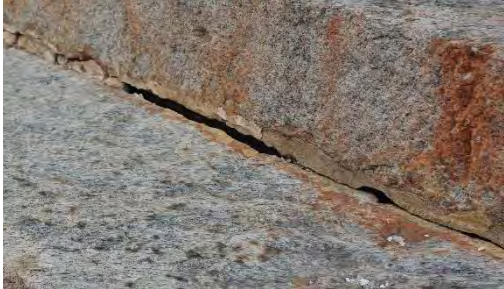
<p>Stone stairs at front portico display extensive mortar deterioration and numerous open joints.</p> <p>Repoint stone foundation wall and match existing mortar in color and composition.</p>	125 SF
MS.2

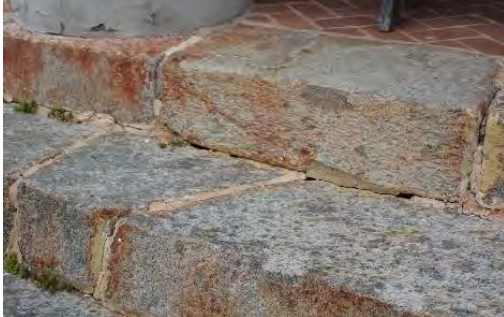
<p>Existing stone and concrete stairs display discoloration and staining.</p> <p>Remove paint and staining from stone stairs and bottom concrete step. Perform tests on masonry and pursue the gentlest effective method.</p>	125 SF
MS.3

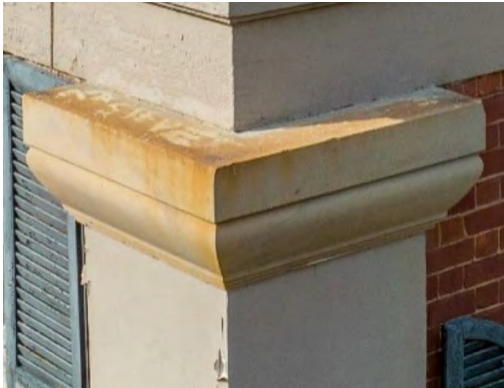
<p>The sky-facing sides of several of the stone capitals have graffiti and various surfaces are stained.</p> <p>Remove paint and clean stains on stone capitals. Removal of all stains is not the intended goal. Clean surface with mild detergent and gentle water wash to remove surface dirt.</p>	18 locations

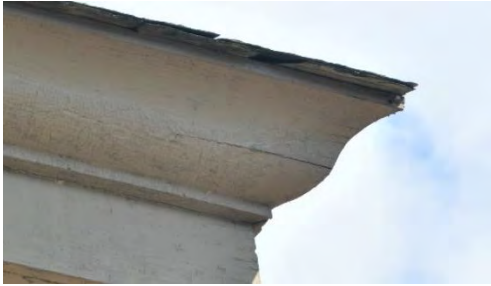
Existing wood cornice board has a split end. Strip finish from damaged portion of wood cornice board. Remove rotted portions of wood and provide wood dutchman or epoxy repairs.	6 LF
WD.2

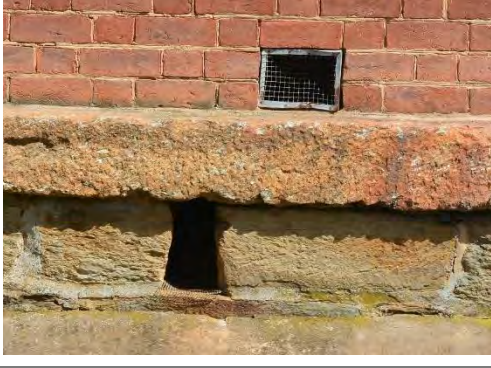
<p>The existing crawlspace vents have a series of mismatched screens which are in varied condition. Debris is entering crawlspace through vents.</p> <p>Remove metal screen. Provide new metal screen in existing opening set back from face of masonry.</p>	10 locations
MT.4

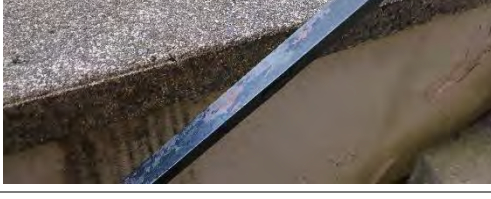
<p>Finish on existing metal railing is deteriorated.</p> <p>Prepare surface of metal handrail. Repaint.</p>	2 locations @ 100 LF total

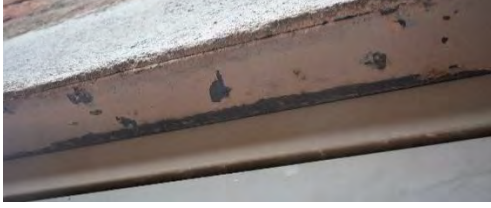
MT.5

<p>Existing metal element displays corrosion.</p> <p>Remove corrosion from surface of metal element. Repair surface deterioration. Paint.</p>	4 LF

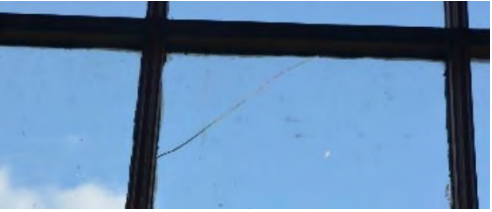
W.4

<p>Existing glass pane is broken. 1 location</p> <p>Remove cracked glass pane. Provide glass pane in existing window.</p>
-----	---	---

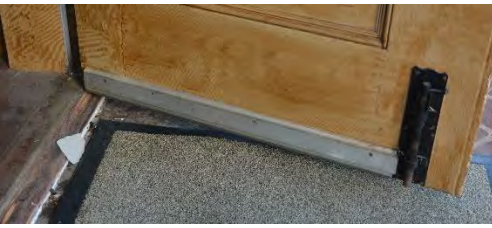
<p>Existing door sweep is damaged and beyond useful life.</p> <p>Remove and replace door sweep.</p>	<p>3 paired doors</p>
D.3

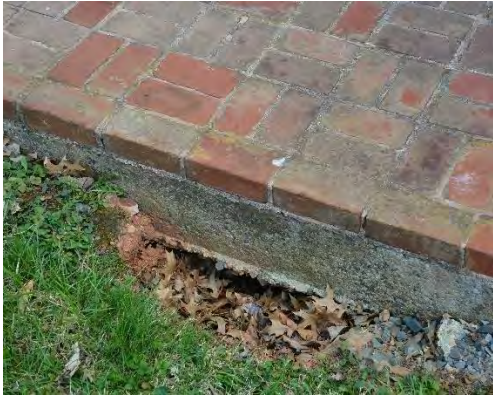
<p>Paving at north side of building has settled, opening a mortar joint and creating a hole adjacent to brick-paved walk.</p> <p>Repoint joint along building at walk. Monitor joint to determine if settlement is active. Provide compacted fill to create level surface up to existing brick paving.</p>	1 instance @ 8 SF
O.2

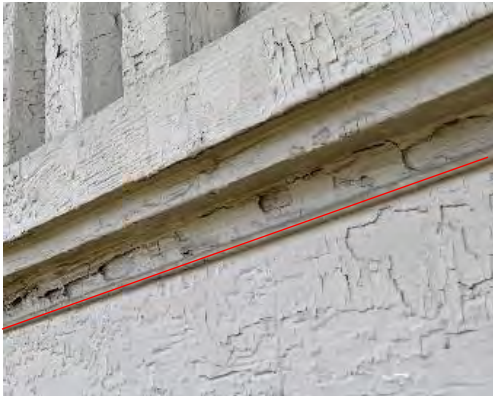
<p>Various types of wiring are mounted to the exterior face of the building. See red highlight line for reference.</p> <p>Determine if wiring is in active service. Reroute surface wiring and remove mounting accessories. Repair surface as necessary. Provide concealed interior wiring.</p>	2 instances
O.3

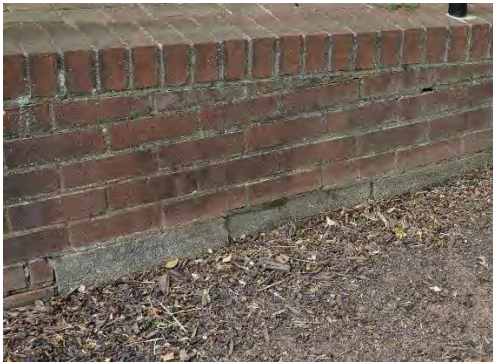
<p>The exterior grade has settled at the face of masonry accessible ramp, revealing the concrete block foundation wall.</p> <p>Regrade planting bed at brick ramp to obscure concrete block foundation wall and create positive slope away from building.</p>	1 location of approx. 40 SF

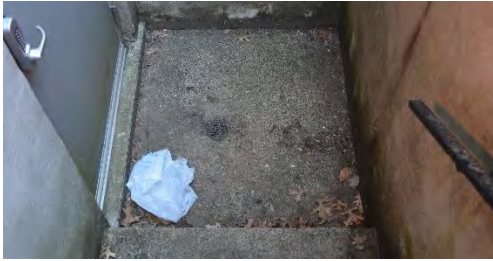
O.4

<p>Debris has collected in basement areaway and soiling has occurred on the stair retaining walls.</p> <p>Clean areaway and basement stair of all dirt and debris.</p>	60 SF

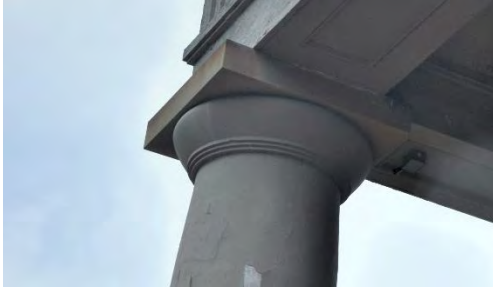
O.5

There is a bird nest on the horizontal surface of a column capital.

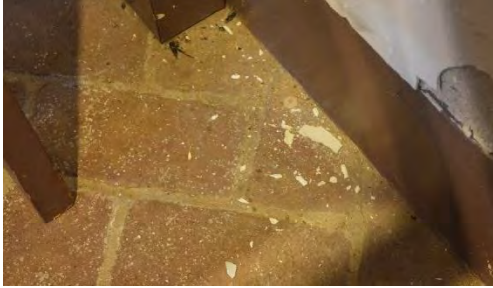
<p>The interior of the building has a minor extent of debris and soiling throughout, especially the basement and upper levels.</p> <p>Clean all interior spaces to remove debris and soiling.</p>	2,500 SF
GI.2

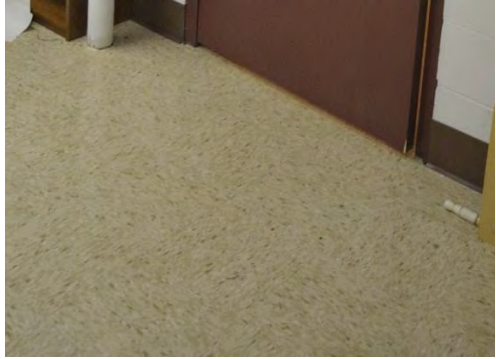
F.2

<p>Existing vinyl composition tile (VCT) flooring displays minor discoloration due to age. Despite discoloration, floor tile is in good condition.</p> <p>As basement is expected to remain back-of-house space, maintain existing flooring and apply protective coating.</p>	780 SF
F.3

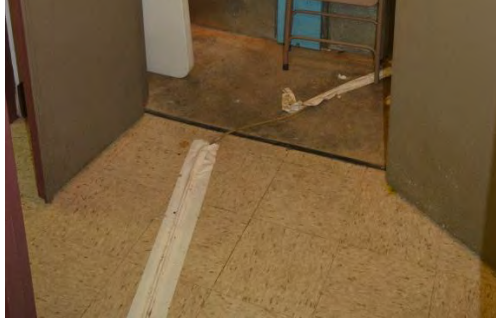
<p>Dehumidifier drain line is taped to floor from registrar's storage room to floor drain in mechanical room.</p> <p>Provide heavy duty protector for condensate line until mechanical upgrades are completed in basement.</p>	1 location at 6 LF
F.4

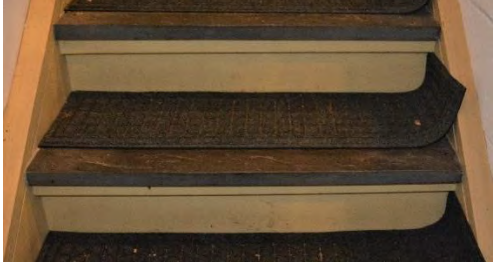
F.5

<p>Stair tread covers do not fit the width of the basement stair treads.</p> <p>Provide broadloom carpet stair runner down center of stair.</p>	20 LF

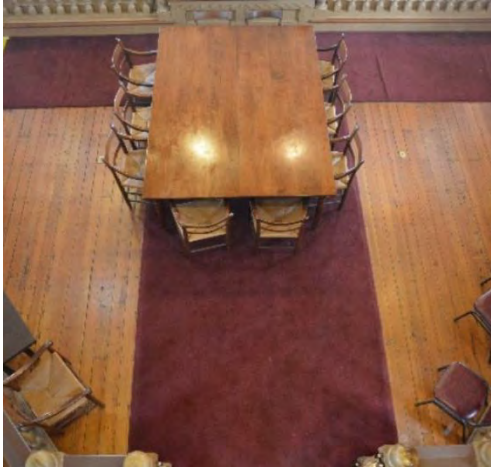
F.6

<p>Broadloom carpet covers a significant portion of the wood floor, preventing the ability to assess its condition.</p> <p>Remove carpet to allow for floor refinishing in courtroom, stairs, and gallery. Provide new broadloom carpet at stairs and gallery to protect stair surface from wear and to maximize safety. Return main courtroom floor to exposed wood flooring.</p> <p>600 SF of carpet removal / 350 SF of new carpet on stairs and gallery</p>
F.7

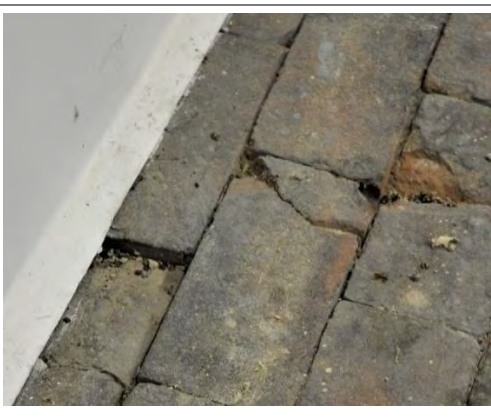
<p>The brick hearths in the jury rooms have several broken bricks.</p> <p>Remove broken bricks. Prepare substrate and reset salvageable units. Replace heavily damaged units with salvaged bricks. Consider removal of the infill panels in each room to restore fireplace.</p> <p>10 units / 2 infill panels</p>

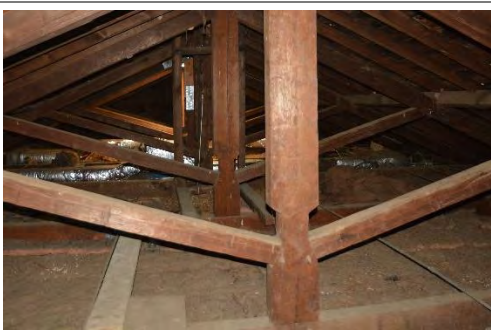
F.9

<p>Attic lacks a walking surface to permit maintenance access across length.</p> <p>Install 4'-0" wide by 3/4" thick plywood decking on existing ceiling joists to create maintenance access path to full length of attic.</p> <p>200 SF</p>

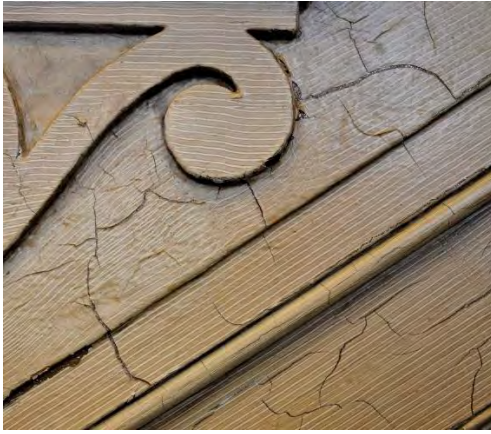
<p>Painted wood graining finish displays deterioration and localized areas of poor execution.</p> <p>Perform interior paint analysis. Remove deteriorated paint finish on all wood surfaces. Prepare surface and repaint 100% of woodwork in courtroom and jury rooms per findings of analysis.</p>	600 SF
WA.2

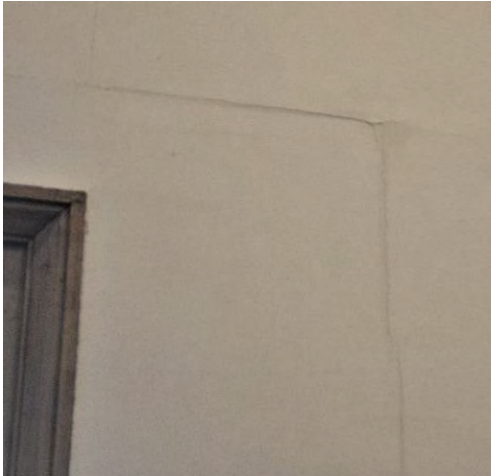
<p>Existing plaster board and plaster wall finish has gaps along joints and localized areas of deterioration.</p> <p>Repair damaged areas of wallboard and plaster finish. Paint 100% of walls. Alternate approach includes removal of all existing wall finish applied on top of historic plaster and repair/replacement of plaster wall finish.</p>	<p>6000 SF of painting / 150 SF of repairs</p> <p>Alternate: Remove applied wall board in courtroom and repair/replace plaster.</p>

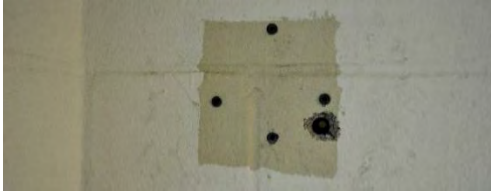
WA.4

<p>Metal fasteners are installed in face of concrete block wall.</p> <p>Remove metal fasteners. Patch wall with mortar. Paint wall.</p>	5 locations
WA.5

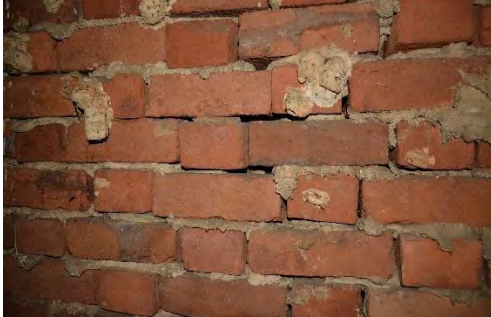
<p>Interior face of brick tympanum on north wall exhibits extensive deterioration of mortar joints and brick displacement.</p> <p>Repoint 100% of interior side of brick tympanum with recommended mortar mixture. Reset displaced brick units.</p>	100 SF
WA.6

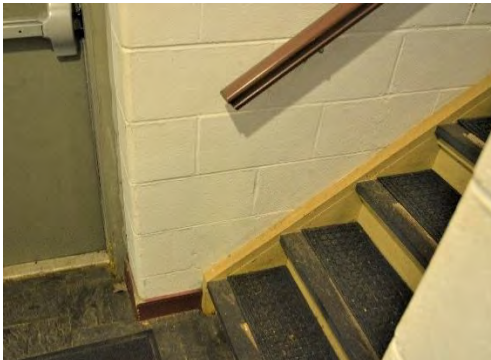
<p>The basement stair handrail does not meet code due to low mounting height and lack of extension at bottom landing.</p> <p>Remove and replace existing basement stair handrail. Relocate light switches at basement landing to accommodate raised handrail.</p>	1 location
WA.7

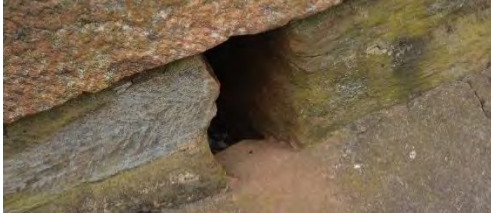
<p>Debris is entering crawlspace area through exterior vents.</p> <p>Remove wall-mounted vents and fans. Inspect crawlspace. Remove debris. Provide vents.</p>	5 locations
WA.8

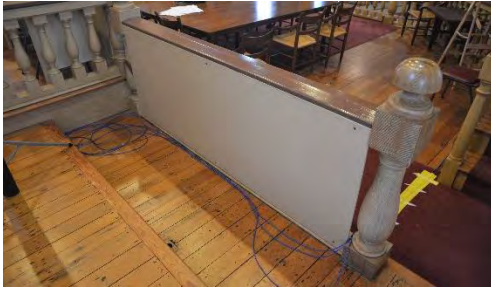
WA.9

Modesty panels were installed on rear side of balustrade at raised judge and jury box in previous renovation.	25 LF
		Remove modesty panels and patch and paint wood at fastener locations.	
WA.10

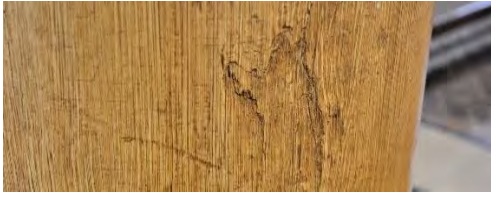
Surface of wood column is damaged.	2 locations @ 1 SF each
		Repair damaged surface. Refinish column.

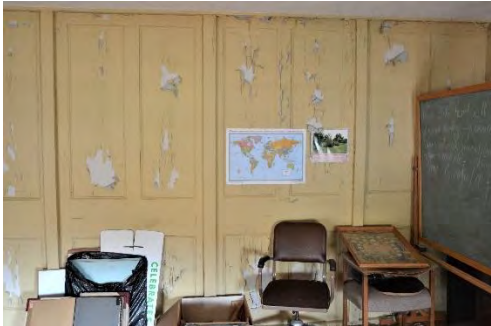
WA.12

Paint finish on operable wood partition is heavily deteriorated.	150 SF
		Remove deteriorated paint finish from operable wood partition on all sides. Repaint. Consider restoring operability to wood panels.

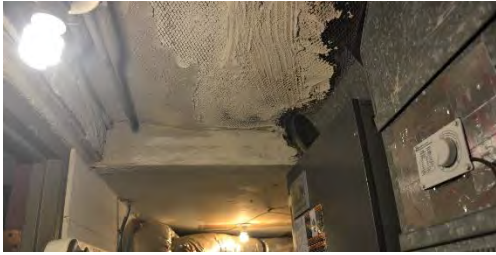
<p>The basement mechanical room ceiling is damaged.</p> <p>Remove damaged metal lath and plaster in mechanical closet. Provide new ceiling in entire mechanical closet.</p>	40 SF
CL.2

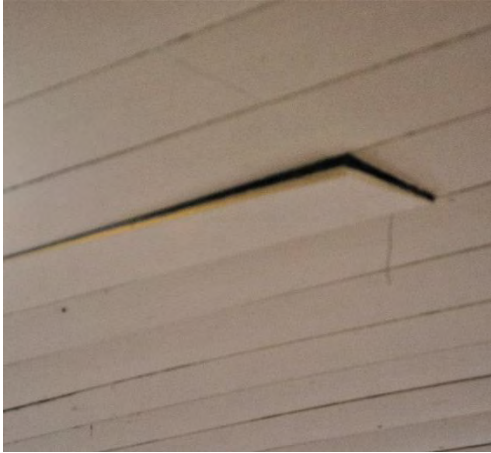
<p>The painted wood board ceiling exhibits minor finish deterioration and several boards have become unfastened over time.</p> <p>Refasten loose ceiling boards and cornice trim. Prepare and repaint 100% of painted wood board ceiling and cornice trim. Coordinate painting with paint analysis findings.</p>	1000 SF of repainting / Assume refastening of 15 ceiling/trim boards
CL.3

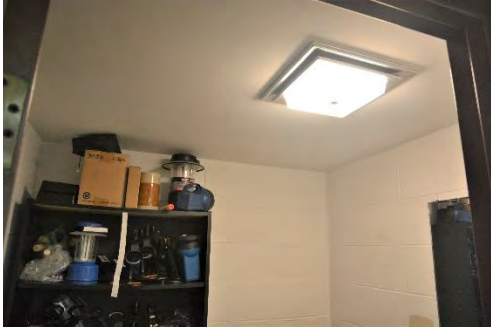
<p>Localized areas of gypsum wallboard ceiling display minor finish deterioration.</p> <p>Patch damaged area of gypsum wallboard ceiling. Prepare and paint 100% of gypsum ceiling.</p>	750 SF of painting / 20 SF of repairs
CL.4

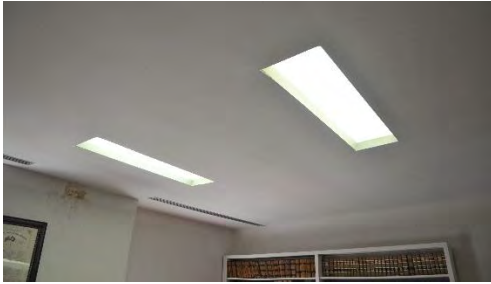
<p>Localized areas of plaster ceiling display minor finish deterioration.</p> <p>Prepare and paint 100% of plaster ceiling. Perform work in concert with plaster repairs in item CL.5.</p>	950 SF

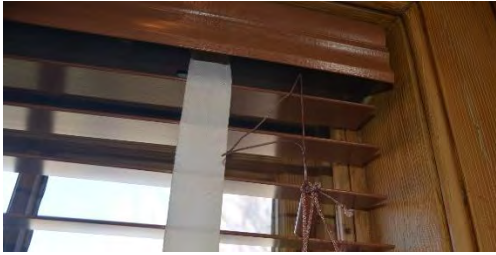
Existing Venetian blinds do not operate with ease and display signs of soiling and age. Remove and replace Venetian blinds.	18 locations
OI.2

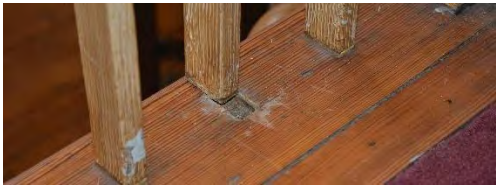
Existing wood stair baluster is loose. Provide wood glue and/or tack to fix baluster in place.	2 locations
OI.4

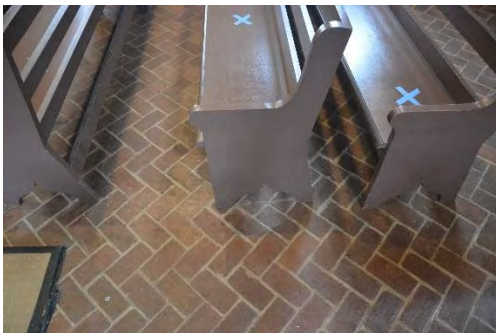
Wood benches and jury room wood shelves display minor finish deterioration and damage. Paint 100% of wood benches and jury room shelves.	65 SF of shelf painting / 135 LF of bench painting

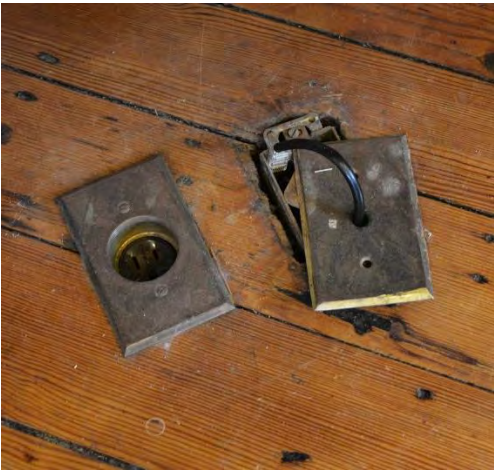
OI.5

<p>Assessment of the electrical and A/V systems were not included in the scope of this project.</p> <p>Full building</p> <p>Complete review and assessment of electrical and A/V systems. Review potential to update all lighting, electrical, and A/V systems as required. Review all floor receptacles in court room. Remove any nonfunctioning receptacles and provide blank off plate.</p>
OI.6

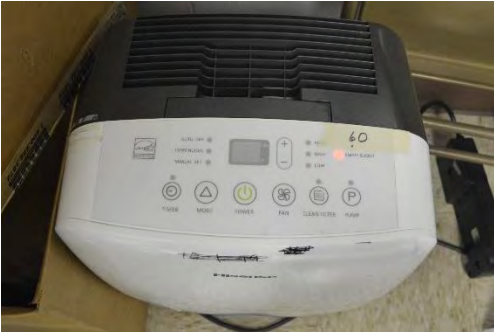
<p>Several dehumidifiers indicate that the buckets are full and require emptying.</p> <p>6 units</p> <p>Until mechanical system upgrades occur, a routine maintenance schedule should be developed for the basement dehumidifiers.</p>

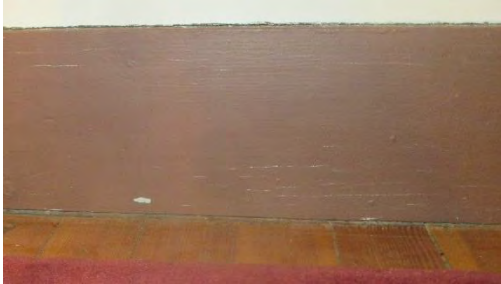
Settlement has occurred at the second-floor gallery evidenced by the small gap at the shoe molding and the floor. Monitor gap at floor and base trim over time to determine if settlement is active.	N/A
S.2

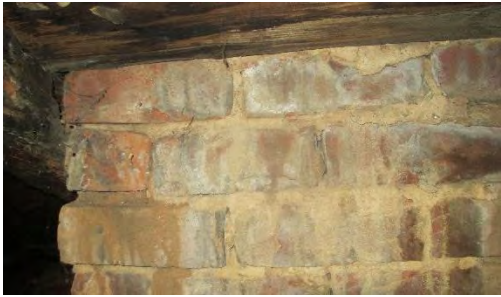
The mortar at the chimneys in the attic displays extensive deterioration. Repoint 100% of three chimneys in attic.	30 SF
S.3

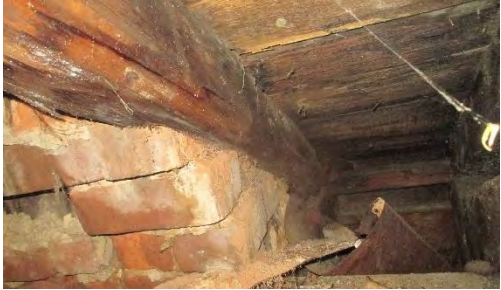
The roof rafters notched into the chimneys have rotted extensively at three of the four chimneys. Remove rotted wood and sister new member onto sound portions of existing member.	2 instances at 3 chimneys
S.4

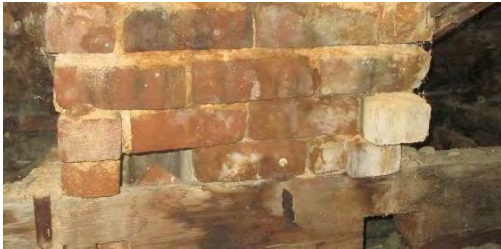
Brick is missing at chimney in attic. Install salvaged brick in missing location. Coordinate with chimney repointing.	1 instance
S.5

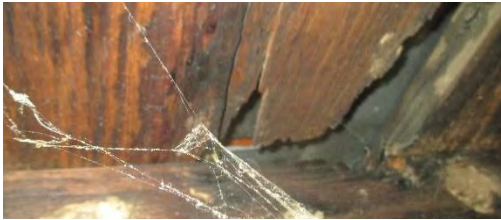
Roof sheathing is rotted due to water infiltration. Replace rotted areas of wood. Coordinate repairs with roofing repairs.	25 SF

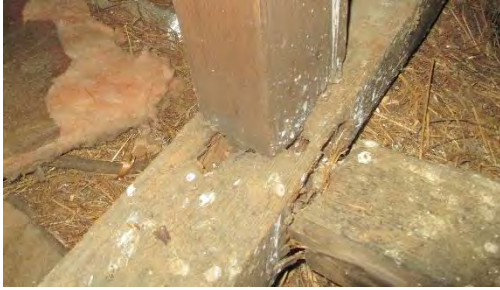
S.6

<p>Post supporting bell enclosure is rotted at roof connection, at bottom of post, and at horizontal support member.</p> <p>Remove and replace bell support members to match existing member.</p>	2 members of 15 LF total
S.7

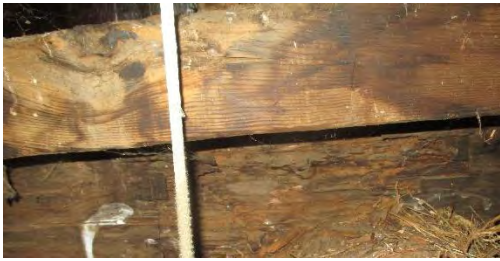
<p>Bottom truss chord beneath king post adjacent to bell enclosure location is rotted.</p> <p>Remove approx. 12" length of rotted wood and sister existing bottom chord on each side.</p>	1 location

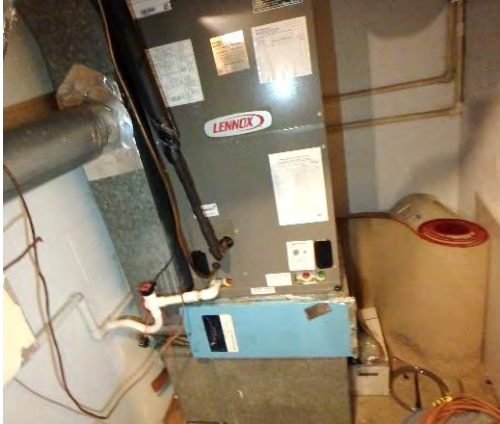
<p>Typical air handler setup (AH-1 shown) with air cleaner at return, condensate drain to pump unit.</p> <p>Regular servicing and tune-ups of all (4) systems are recommended twice annually at season changes.</p>	4 AHUs
M.2

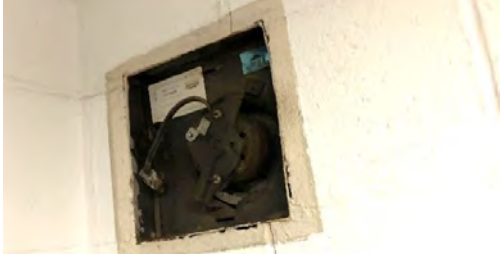
<p>Basement wall exhaust fans are of dated vintage and do not appear to be operative.</p> <p>Replace fans, wall switches, and existing open-ended outside air intake duct.</p>	3 wall exhaust fans, 3 switches, and 15 LF of ductwork
M.3

- M.2 Replace fans, wall switches, and existing open-ended outside air intake duct.

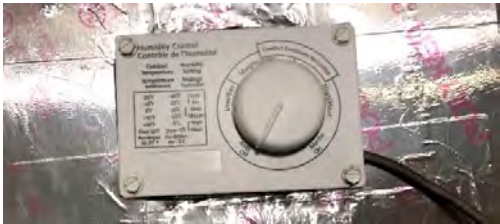
<p>Basement has build-up of humidity.</p> <p>Test all humidifiers and associated controls to confirm proper operation.</p>	3 total
M.4

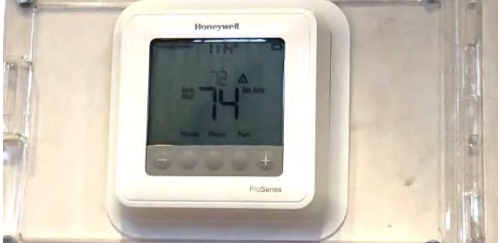
<p>Existing thermostats require calibration.</p> <p>Calibrate existing thermostats to confirm accurate operation and ability to maintain desired indoor temperature conditions.</p>	4 total

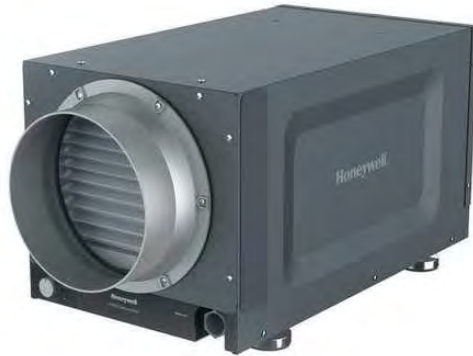
M.8

Basement humidity levels are excessive and damaging to paper documents. Portable dehumidifiers appear to be ineffective for mitigating this problem.

Install a ducted dehumidifier and associated interior ductwork to serve the Basement level. This also may require an exhaust fan to remove the heat generated by the dehumidifier.

Provide 1 dehumidifier, humidistat with return/supply ductwork; 1 exhaust fan, associated exhaust duct and exterior louver

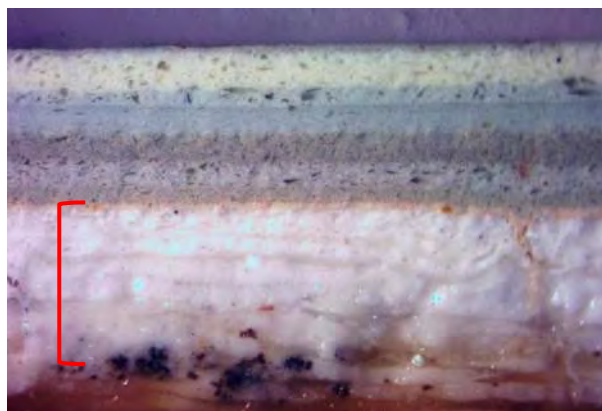
Figure B1. FP-07 with indicated benchmark series of creams followed by modern pinkish taupe layer

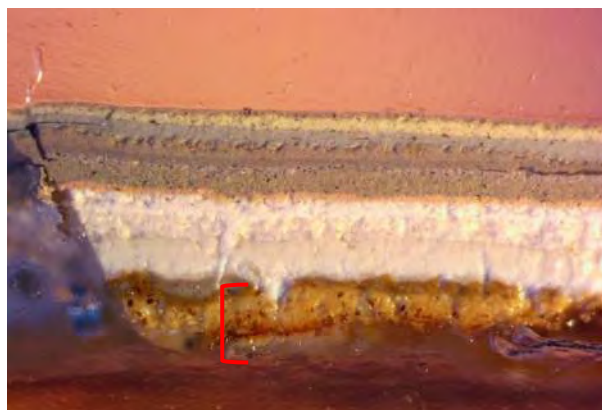
Figure B2. FP-09 showing possible graining of doors in Scheme 1 at indicated layers below benchmark series.

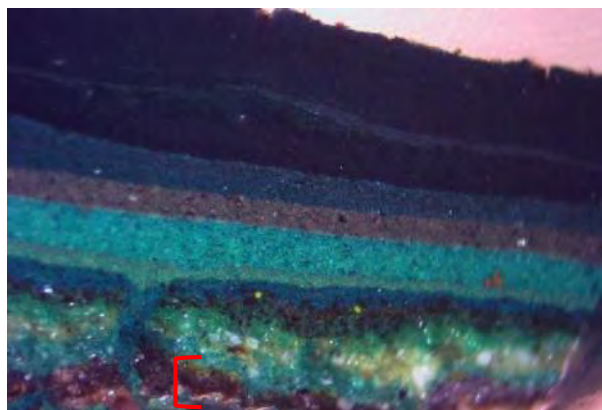
Figure B3. FP-23 showing possible black or very dark green shutters of Scheme 1 where indicated below modern layers.

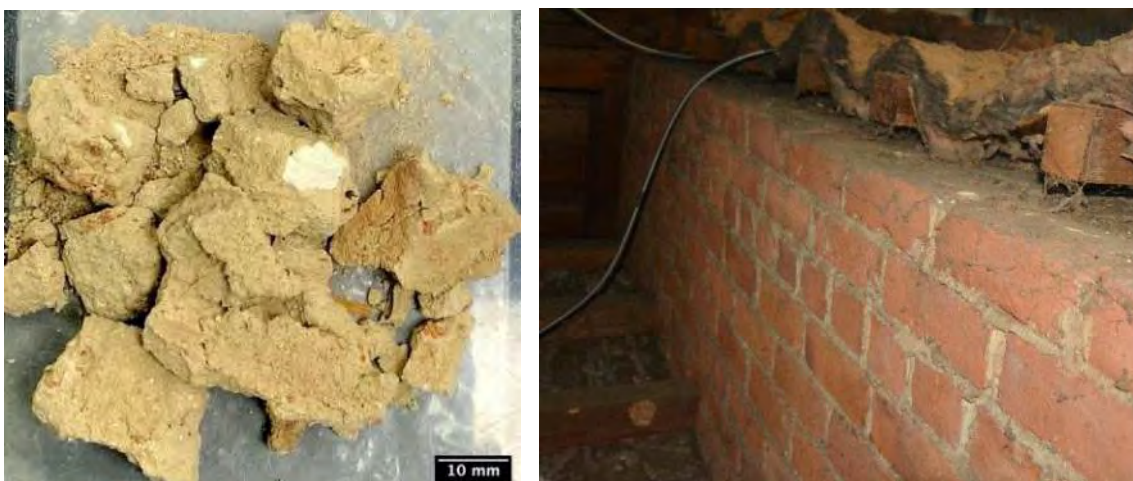
Figure B9. Mortar sample FM-01 and location from south elevation brick wall exposed in attic.

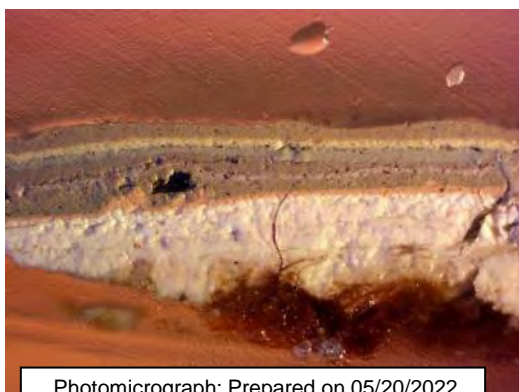
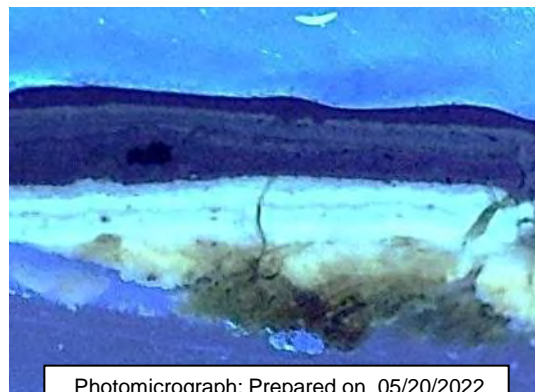
Comments: The layers of grayish white paint followed by a thin layer of moderate yellowish pink is a benchmark sequence found in most of the samples. We do not have an exact timeline of schemes but we know the wood trim and doors were painted white in the early 20th century from photographs. The multiple layers suggest the trim was painted white for a number of years. We have identified this series as "Scheme 2" in our color chart. The UV glow of the white paints suggest oil binders.

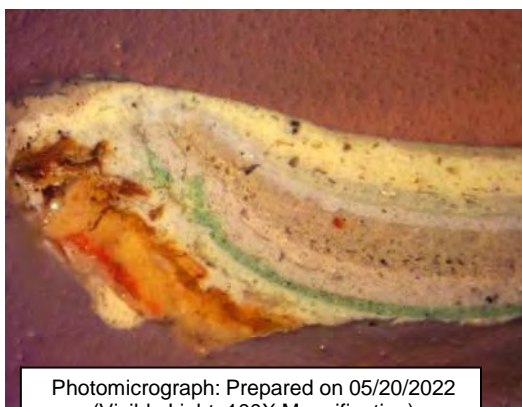
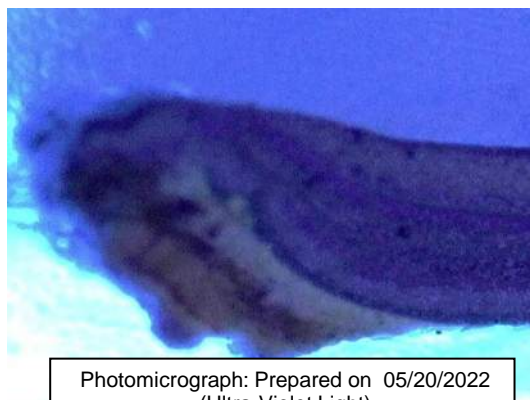
Comments: This sample shows a different color scheme that seems to predate the white scheme found in other samples. This sample in combination FP03 and FP09 suggest the doors may have had a varnished faux-grained scheme at some point. The doors have a different paint stratigraphy than the wood trim. Exposure window in the paint may confirm/reveal what the graining looked like. This scheme is identified as "Scheme 1".

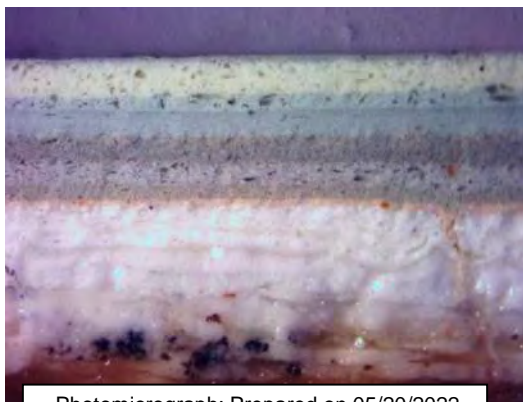
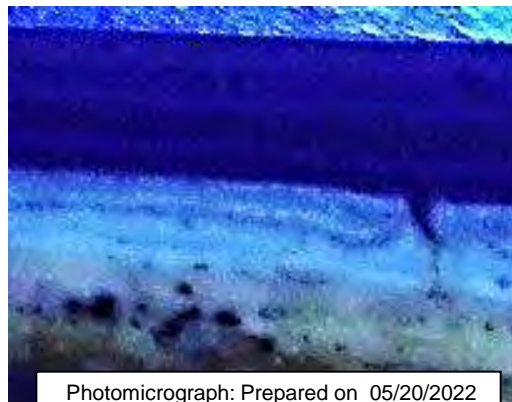
Comments: This sample shows some degradation of the finish just above the wood which perhaps indicates the previous finish was sanded or removed. The many layers of white confirm "Scheme 2" in the color chart.

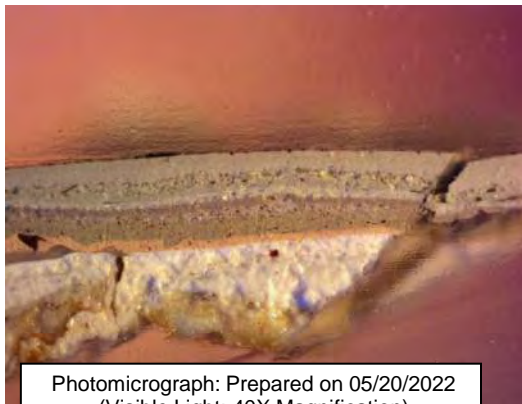
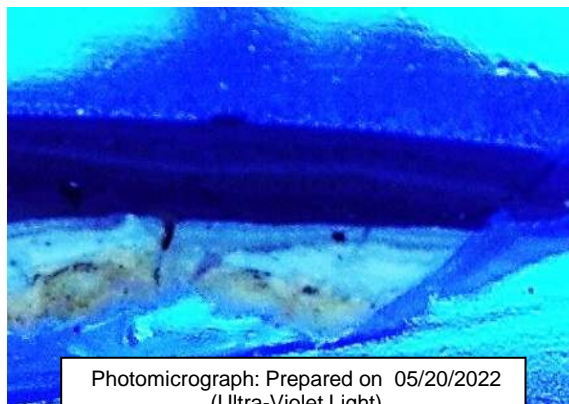
Comments: The layers of grayish white paint followed by a thin layer of moderate yellowish pink is a benchmark sequence found in most of the samples. We do not have an exact timeline of schemes but we know the wood trim and doors were painted white in the early 20th century from photographs. The multiple layers suggest the trim was painted white for a number of years. We have identified this series as "Scheme 2" in our color chart. The UV glow of the white paints suggest oil binders.

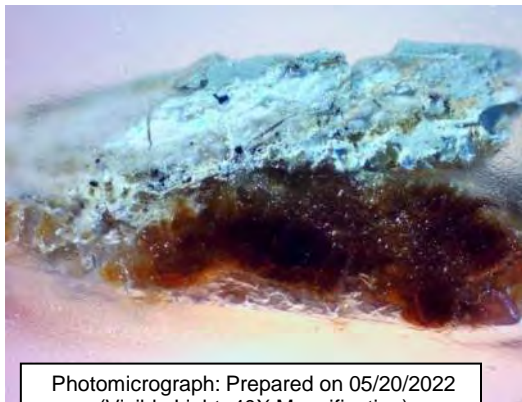
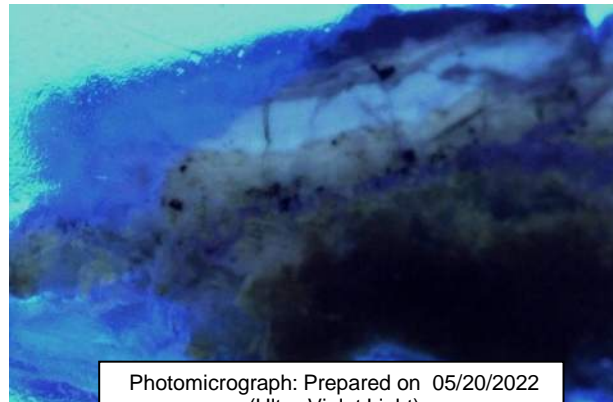
Comments: The layers of grayish white paint followed by a thin layer of moderate yellowish pink is a benchmark sequence found in most of the samples. We do not have an exact timeline of schemes but we know the wood trim and doors were painted white in the early 20th century from photographs. The multiple layers suggest the trim was painted white for a number of years. We have identified this series as "Scheme 2" in our color chart. The UV glow of the white paints suggest oil binders.

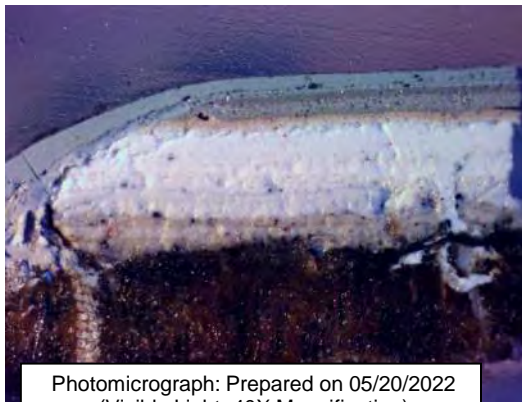
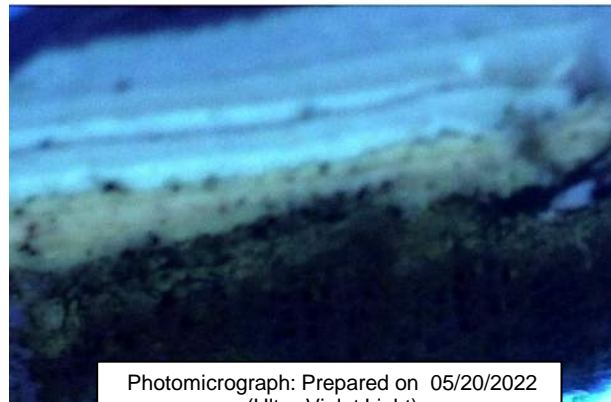
Comments: The layers of grayish white paint followed by a thin layer of moderate yellowish pink is a benchmark sequence found in most of the samples. We do not have an exact timeline of schemes but we know the wood trim and doors were painted white in the early 20th century from photographs. The multiple layers suggest the trim was painted white for a number of years. We have identified this series as "Scheme 2" in our color chart. The UV glow of the white paints suggest oil binders.

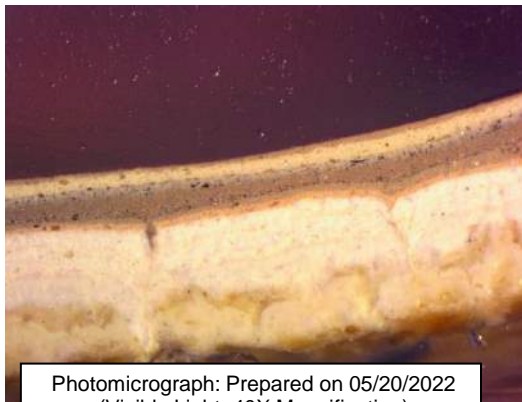
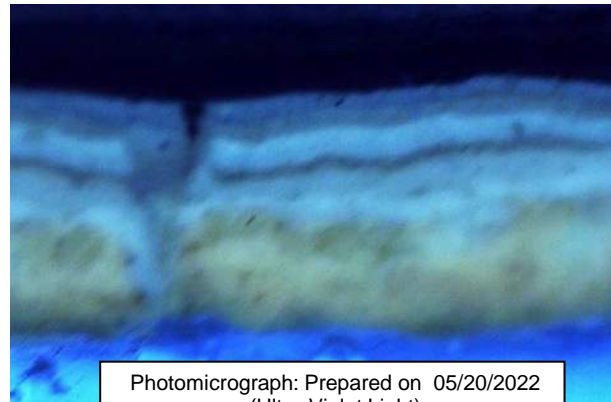
Comments: The layers of grayish white paint followed by a thin layer of moderate yellowish pink is a benchmark sequence found in most of the samples. We do not have an exact timeline of schemes but we know the wood trim and doors were painted white in the early 20th century from photographs. The multiple layers suggest the trim was painted white for a number of years. We have identified this series as "Scheme 2" in our color chart. The UV glow of the white paints suggest oil binders.

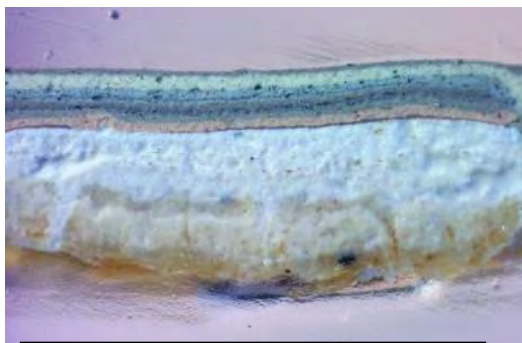
Comments: The layers of grayish white paint followed by a thin layer of moderate yellowish pink is a benchmark sequence found in most of the samples. We do not have an exact timeline of schemes but we know the wood trim and doors were painted white in the early 20th century from photographs. The multiple layers suggest the trim was painted white for a number of years. We have identified this series as "Scheme 2" in our color chart. The UV glow of the white paints suggest oil binders.

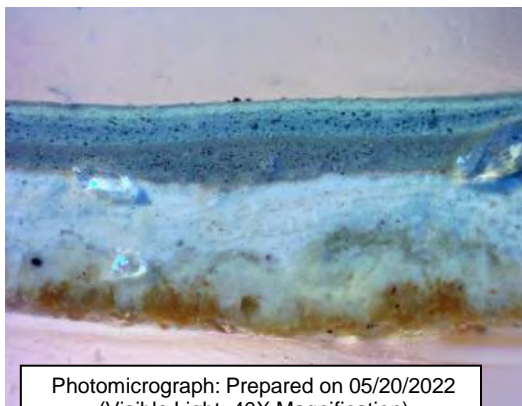
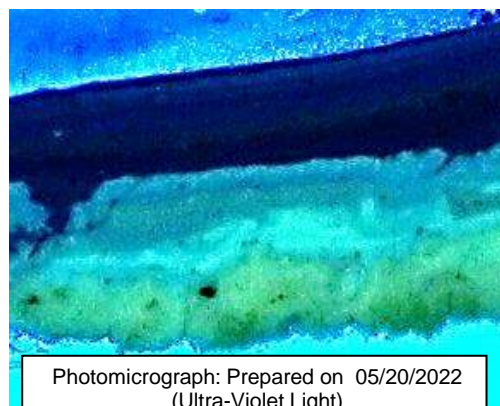
Element Type: Entablature Triglyph

Comments: The layers of grayish white paint followed by a thin layer of moderate yellowish pink is a benchmark sequence found in most of the samples. We do not have an exact timeline of schemes but we know the wood trim and doors were painted white in the early 20th century from photographs. The multiple layers suggest the trim was painted white for a number of years. We have identified this series as "Scheme 2" in our color chart. The UV glow of the white paints suggest oil binders.

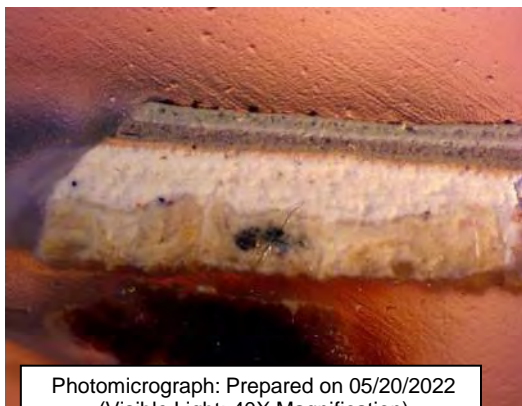
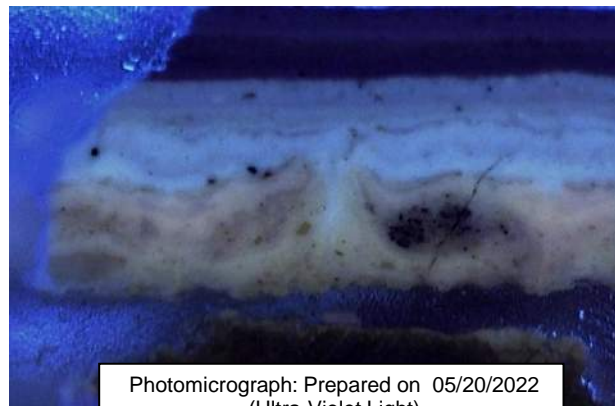
Element Type: Upper Window Frame

Comments: The layers of grayish white paint followed by a thin layer of moderate yellowish pink is a benchmark sequence found in most of the samples. We do not have an exact timeline of schemes but we know the wood trim and doors were painted white in the early 20th century from photographs. The multiple layers suggest the trim was painted white for a number of years. We have identified this series as "Scheme 2" in our color chart. The UV glow of the white paints suggest oil binders.

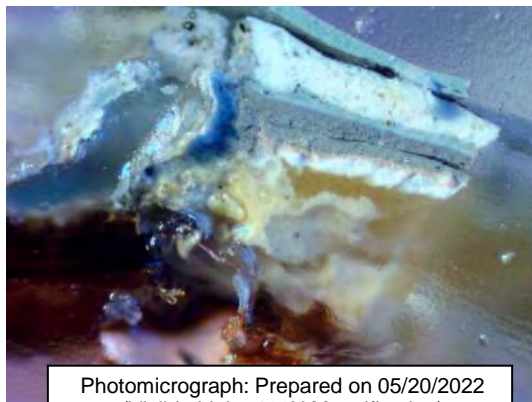
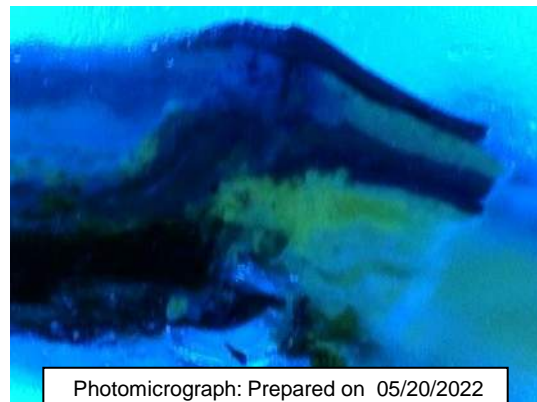
Element Type: Upper Window Sash

Comments: The layers of grayish white paint followed by a thin layer of moderate yellowish pink is a benchmark sequence found in most of the samples. We do not have an exact timeline of schemes but we know the wood trim and doors were painted white in the early 20th century from photographs. The multiple layers suggest the trim was painted white for a number of years. We have identified this series as "Scheme 2" in our color chart. The UV glow of the white paints suggest oil binders.

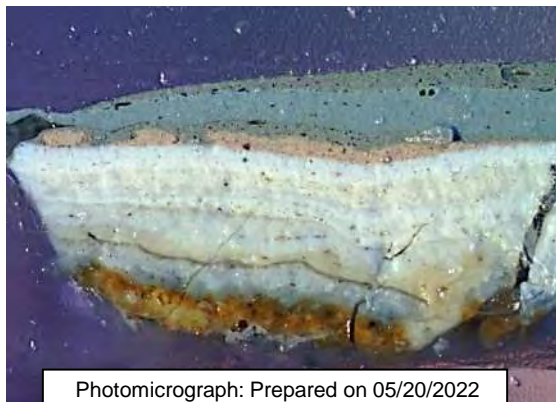
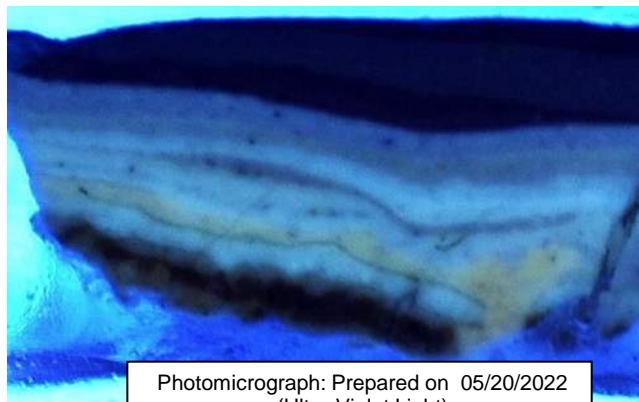
Element Type: Door Stile

Comments: This sample has some of the early yellows and potential faux-grain identified as "Scheme 1." The blue layer is an outlier from all the samples and may represent an anomaly or a degradation of a white layer. The layers of grayish white paint followed by a thin layer of moderate yellowish pink is a benchmark sequence found in most of the samples. We do not have an exact timeline of schemes but we know the wood trim and doors were painted white in the early 20th century from photographs. The multiple layers suggest the trim was painted white for a number of years. We have identified this series as "Scheme 2" in our color chart. The UV glow of the white paints suggest oil binders.

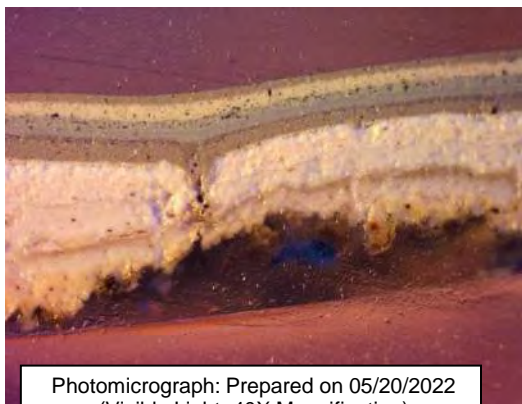
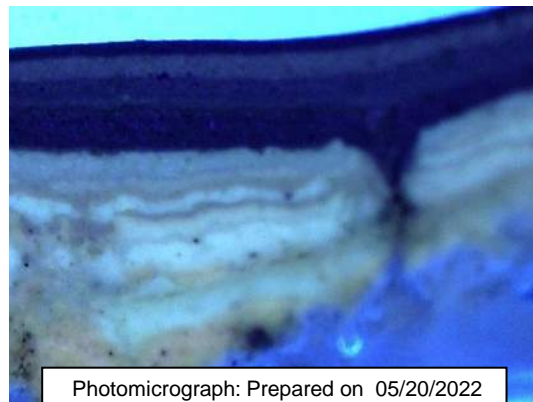
Element Type: Transom Sash

Comments: This sample has some of the early yellows and potential faux-grain identified as "Scheme 1." The layers of grayish white paint is missing the thin layer of moderate yellowish pink that was part of the benchmark sequence found in most of the samples. We do not have an exact timeline of schemes but we know the wood trim and doors were painted white in the early 20th century from photographs. The multiple layers suggest the trim was painted white for a number of years. We have identified this series as "Scheme 2" in our color chart. The UV glow of the white paints suggest oil binders.
