HISTORIC STRUCTURE REPORT
FLUVANNA COUNTY HISTORIC COURTHOUSE
COUNTY OF FLUVANNA, VIRGINIA

HISTORIC STRUCTURE REPORT

FINAL REPORT

September 7, 2022

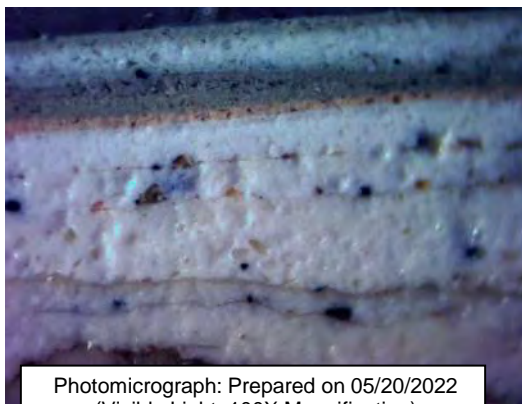
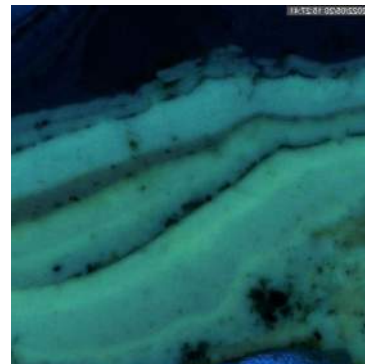
Element Type: Soffit Frame

Comments: The layers of grayish white paint followed by a thin layer of moderate yellowish pink is a benchmark sequence found in most of the samples. We do not have an exact timeline of schemes but we know the wood trim and doors were painted white in the early 20th century from photographs. The multiple layers suggest the trim was painted white for a number of years. We have identified this series as "Scheme 2" in our color chart. The UV glow of the white paints suggest oil binders.

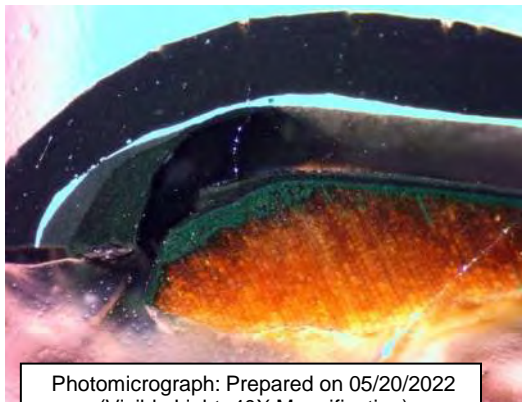
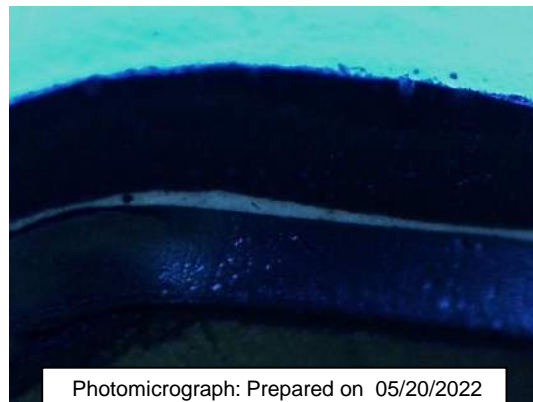
Element Type: Window Shutter

Comments: Most of the paint layers in the sample lay flat suggesting modern paints. This sample confirms that the shutters have been painted green for a long period of time but does not provide information about earlier paint colors.

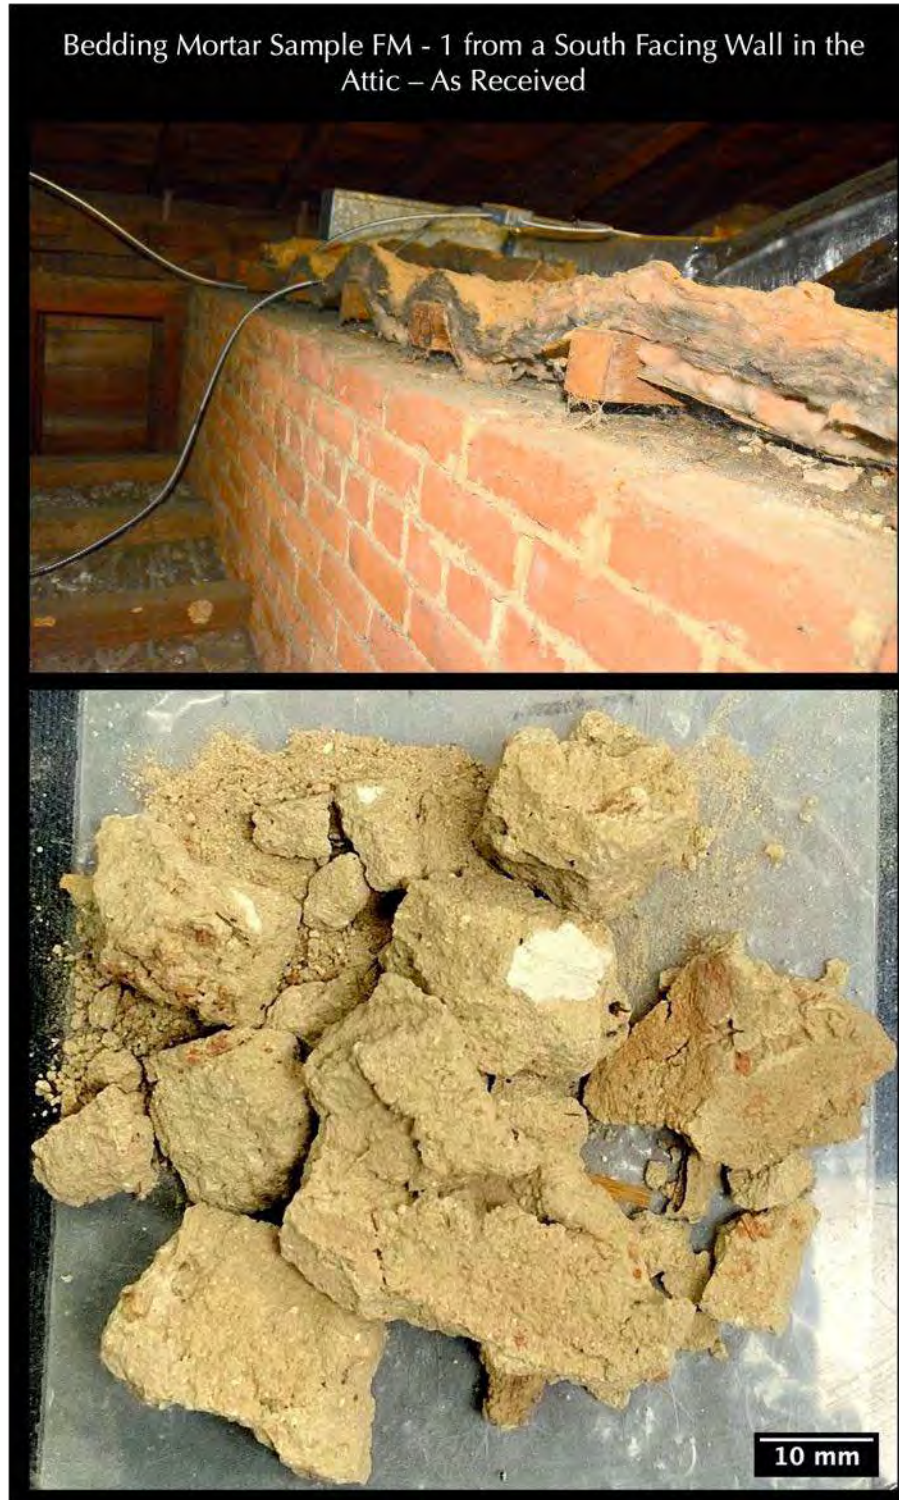
Figure 2: Location of the bed joint (top photo) from where the tan-colored fragments of mortar sample (bottom photo) was collected.

The mortar fragments are moderately hard to soft, where individual fragments are relatively intact.

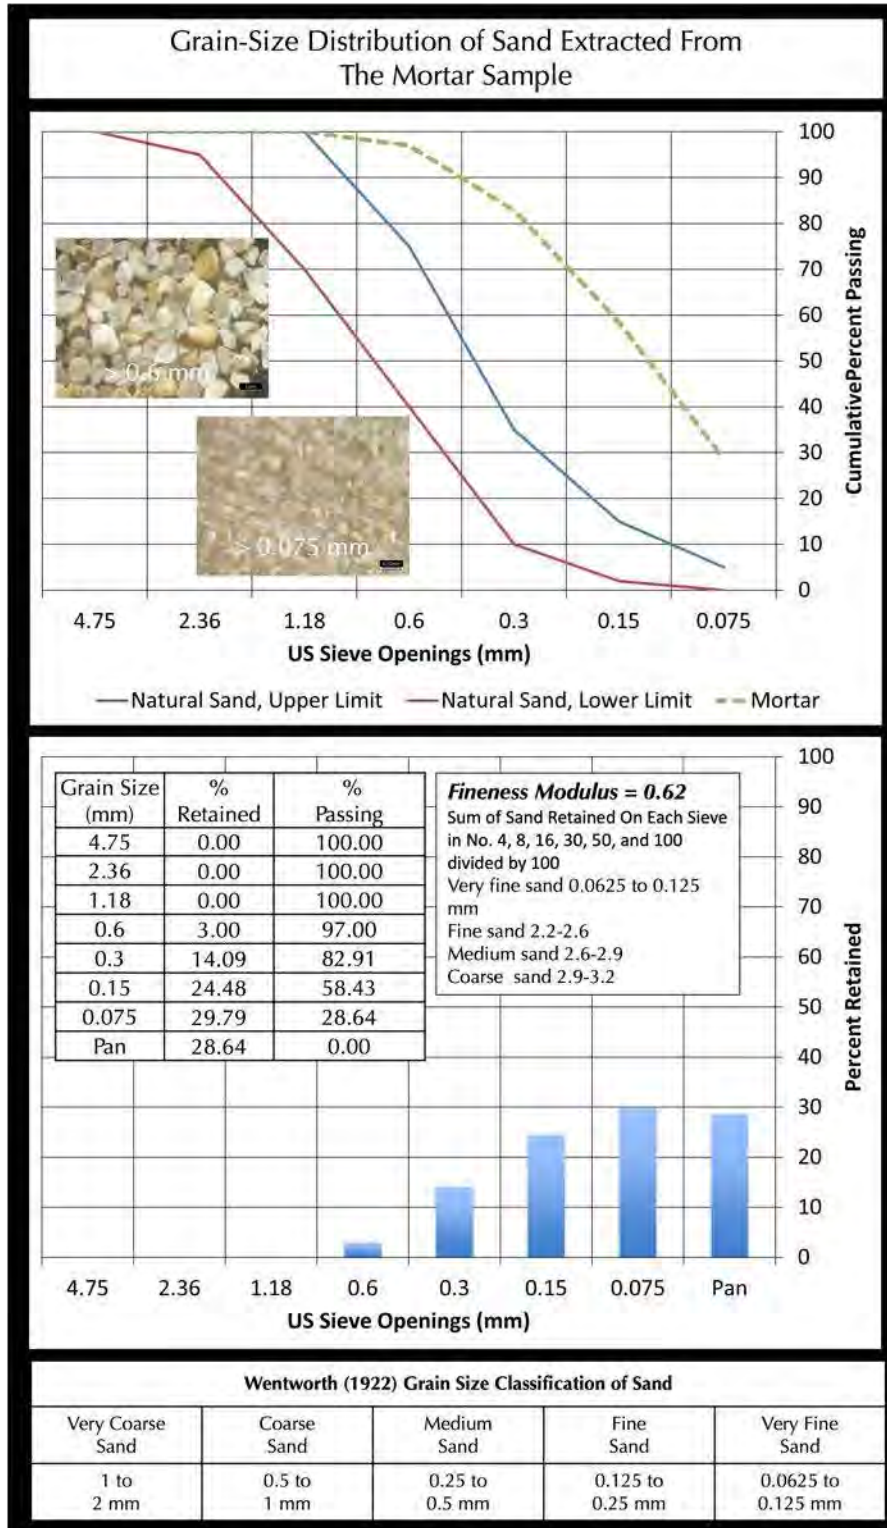
Figure 3: Grain-size distribution of sand extracted from the mortar after hydrochloric acid digestion.

In the top plot, grain size distribution of sand is compared with the upper and lower limits of natural sand in ASTM C 144 (blue and red lines, respectively) showing overall noticeably finer grain size distribution of sand compared to the size distribution of modern ASTM C 144 masonry sand.

Fineness modulus of sand is calculated to be 0.62 from the sum of cumulative percent retained on Sieves 4, 8, 16, 30, 50, and 100 divided by 100 where sand size is very fine as depicted from very low fineness modulus.

Grain-size distribution of sand extracted from the mortar after hydrochloric acid digestion showed very fine size fractions of sand (Figure 3) which are noticeably finer than the size distribution of modern masonry sand. Fineness modulus of sand determined to be only 0.62 with most of the size fractions concentrated in the less than 0.3 mm size. Figure 4 shows color, size, shape, angularity, and gradation of sand particles extracted from the mortar after acid digestion.

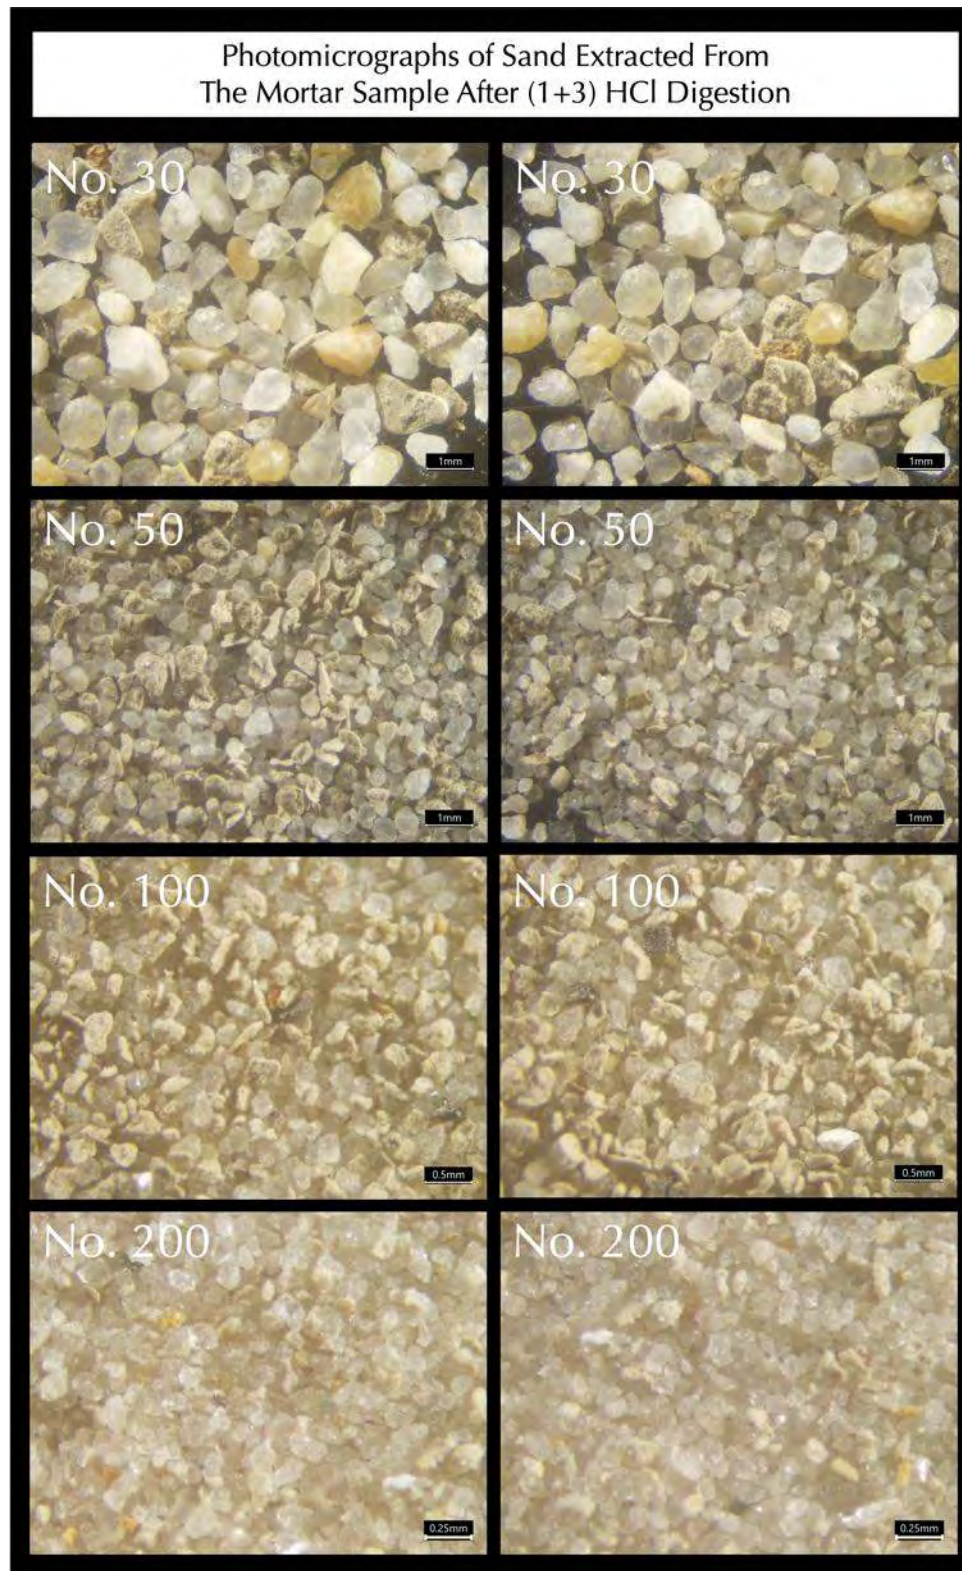
Figure 4: Micrographs of extracted sand from mortar retained on various sieves. Sand particles are off-white light to medium gray, and brown. Most sand particles are subangular to subrounded and equidimensional/equant in shape.

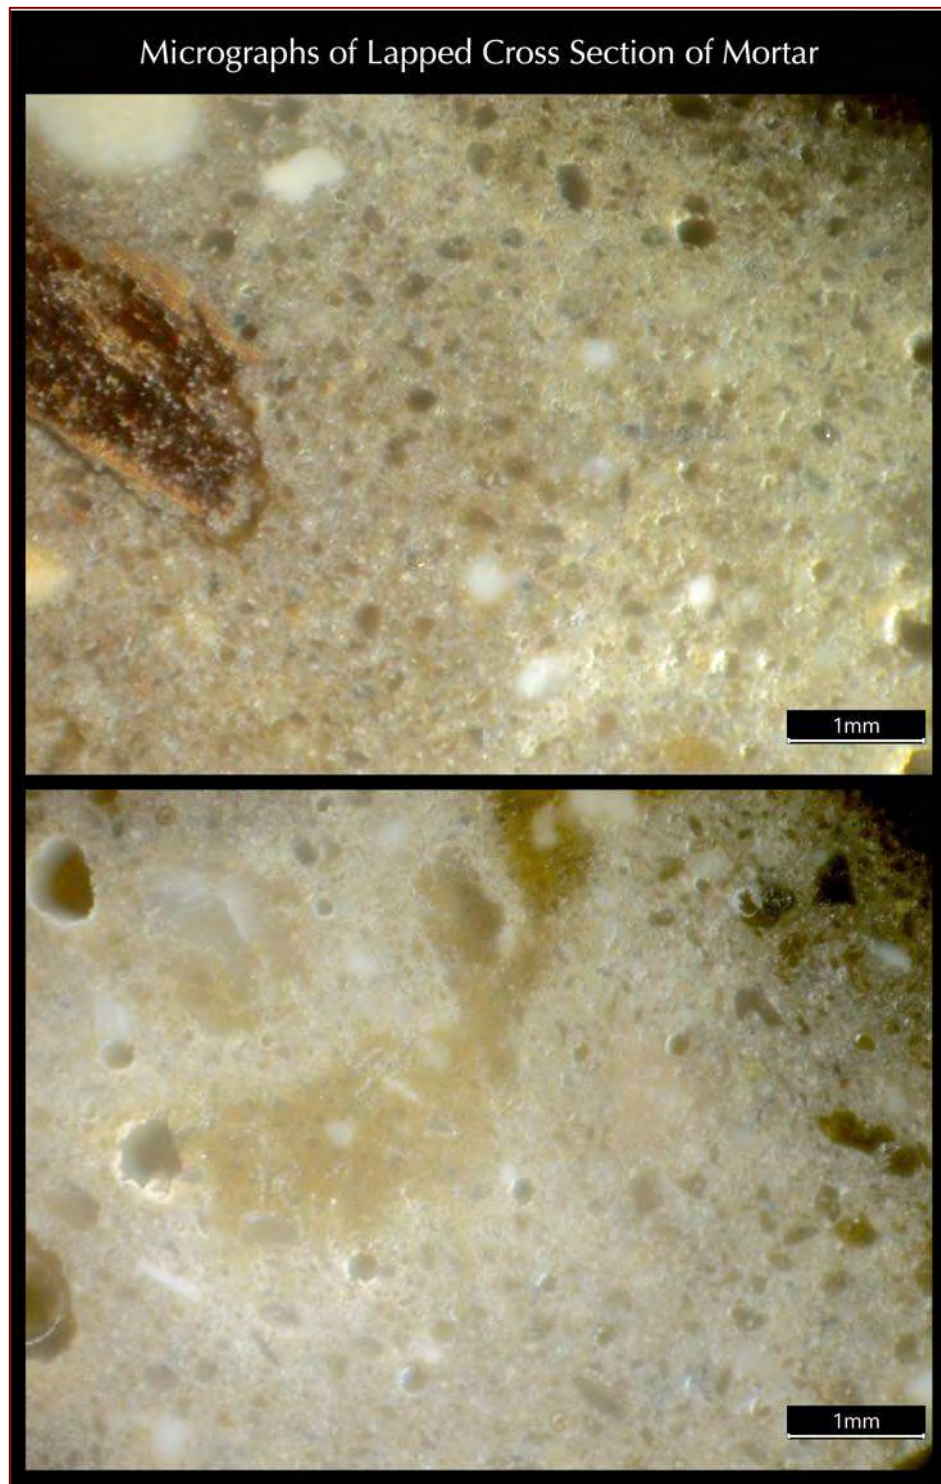
Figure 7: Micrographs of clear epoxy-impregnated cross section of mortar showing size, shape, angularity, gradation, and distribution of sand particles, where particles are variably colored, subangular to subrounded, equidimensional, well graded, and well-distributed. Notice the overall non-air-entrained nature of mortar, which is typical of historic mortars consistent with the reported early 19th century vintage.

Mortar is **non-air-entrained**, which is depicted in micrographs of lapped section in Figure 7 as well as in thin section in Figure 10, which is not unusual for its reported early 19th century derivation.

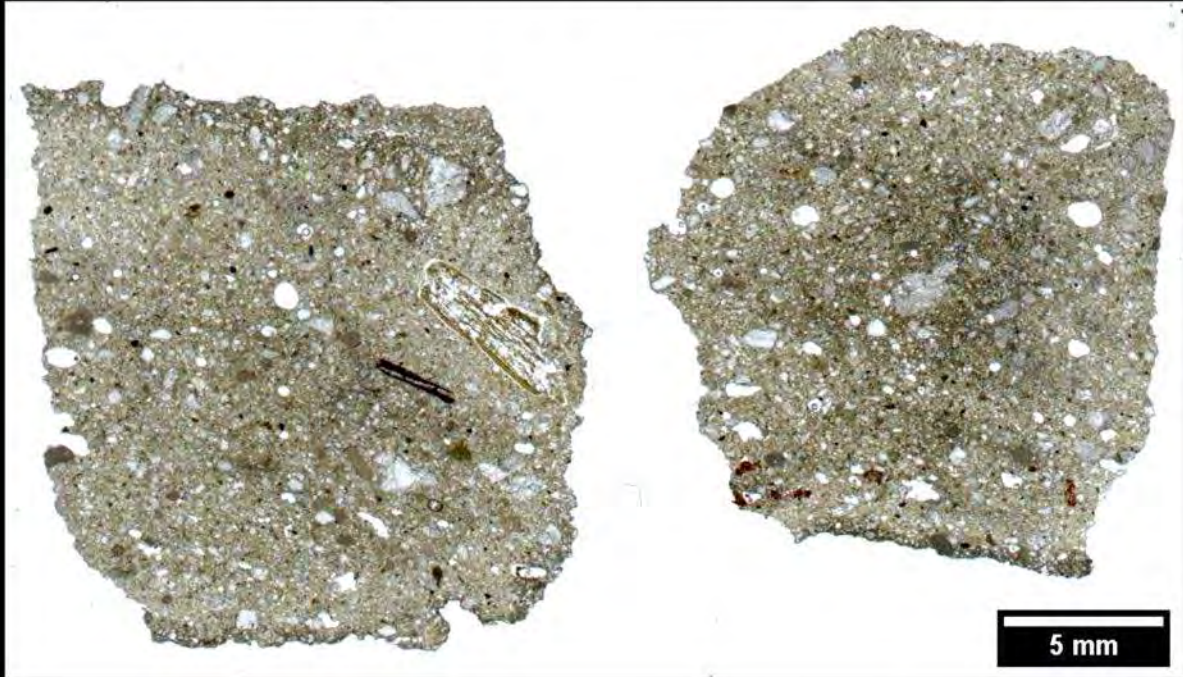
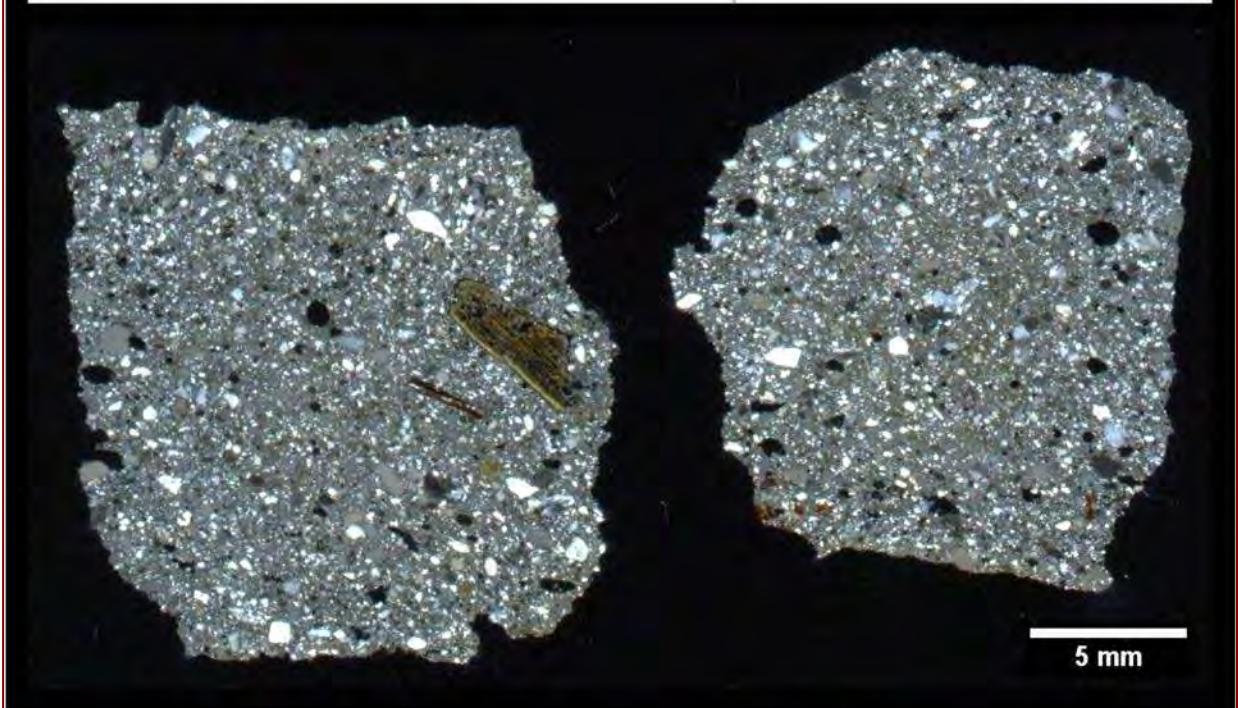
Figure 9: Clear, low viscosity epoxy-impregnated thin section of mortar taken by using a flatbed film scanner, where thin section was scanned with a polarizing filter to generate the plane polarized light (PPL) view of mortar in the top photo, and with two perpendicular polarizing filters to generate the cross polarized light (XPL) view in the bottom photo. Both photos show the very fine (< 1 mm) sand grain size, shape, angularity, and distribution. Notice a few plant fragments accidentally incorporated into the mortar during mixing and installation.

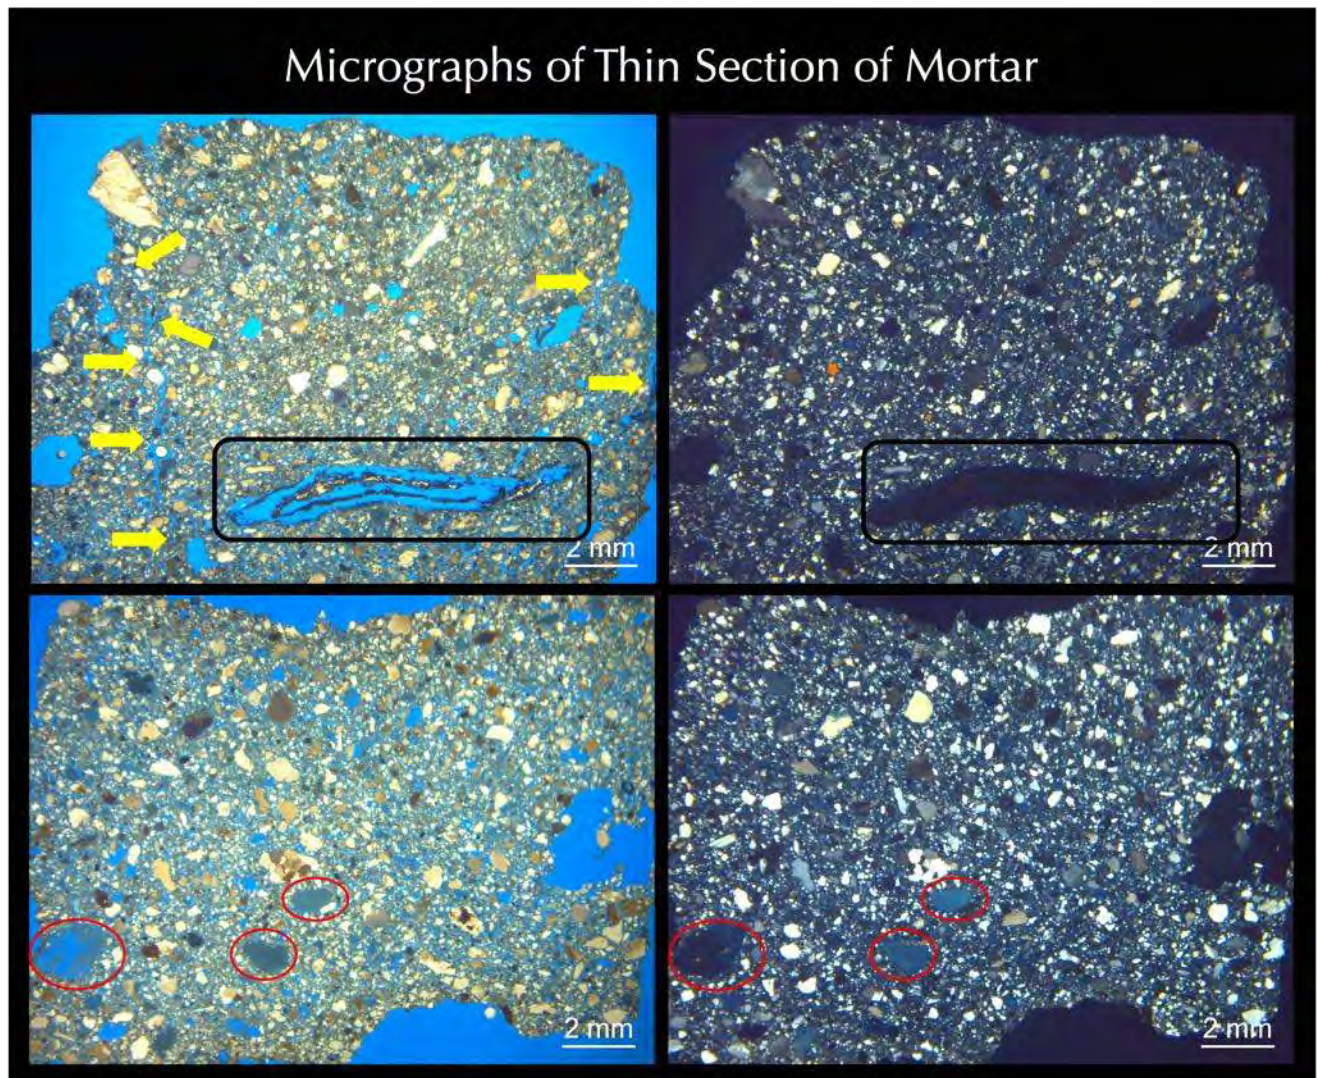
Figure 10: Micrographs of thin section of mortar taken at PPL (left column) and corresponding XPL (right column) modes in a transmitted-light stereo-zoom microscope with polarizing facility where PPL photos show the size, shape, angularity, gradation and distribution of sand particles as well as interstitial pore spaces and micrographs highlighted by the blue epoxy (yellow arrows highlight microcracks), whereas XPL photos show the overall siliceous composition of sand and dark near-isotropic nature of the interstitial paste fraction, as opposed to severely carbonated nature typical of many historic lime mortars, which indicates the presence of a component other than lime which has produced the dark near-isotropic appearance of the interstitial paste. A few unmixed lumps of lime are marked with red ellipses in the bottom row photos.

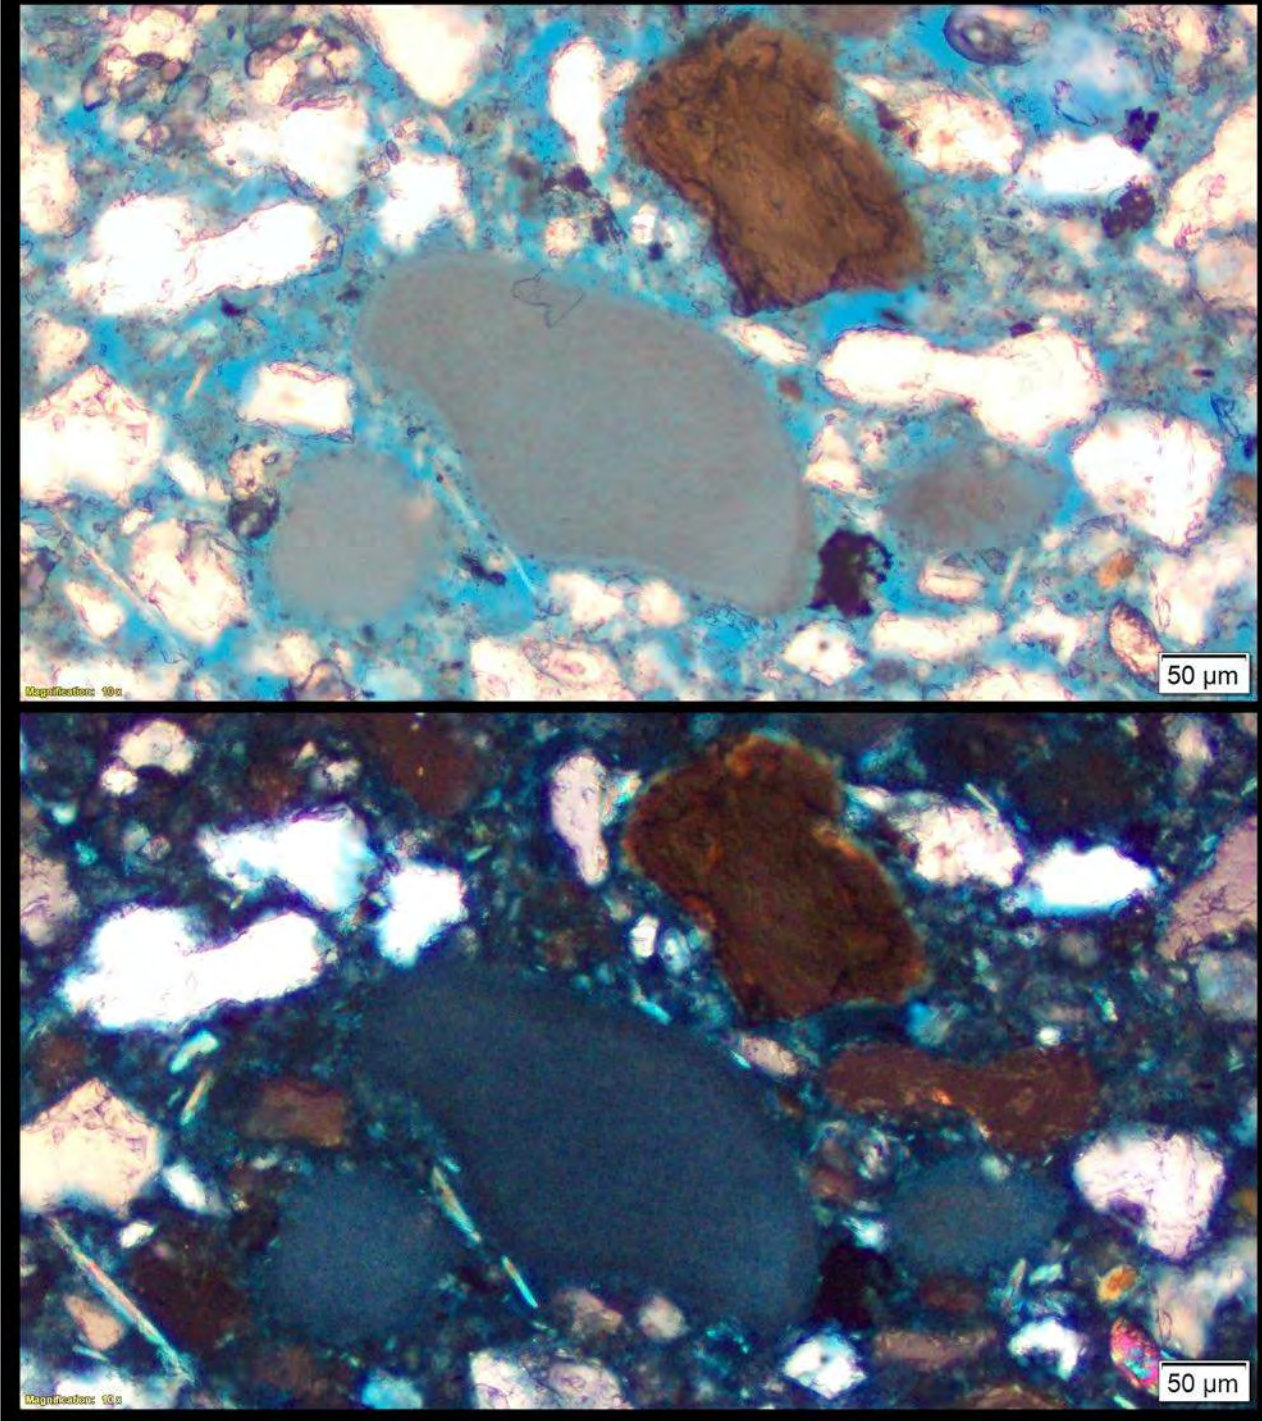
Figure 11: Micrographs of thin section of mortar showing: (a) very fine-grained, porous, carbonated to near-isotropic appearance of interstitial paste fraction; (b) subangular to subrounded, mostly equidimensional siliceous sand particles that are <1 mm in size, (c) some sheet-like flakes of mica and potential clay minerals, (d) a few lumps of unmixed lime that also shows a near-isotropic nature in XPL photo (bottom) as opposed to severely carbonated nature commonly found in lime lumps in many historic mortars, and (e) the non-air-entrained nature of mortar.

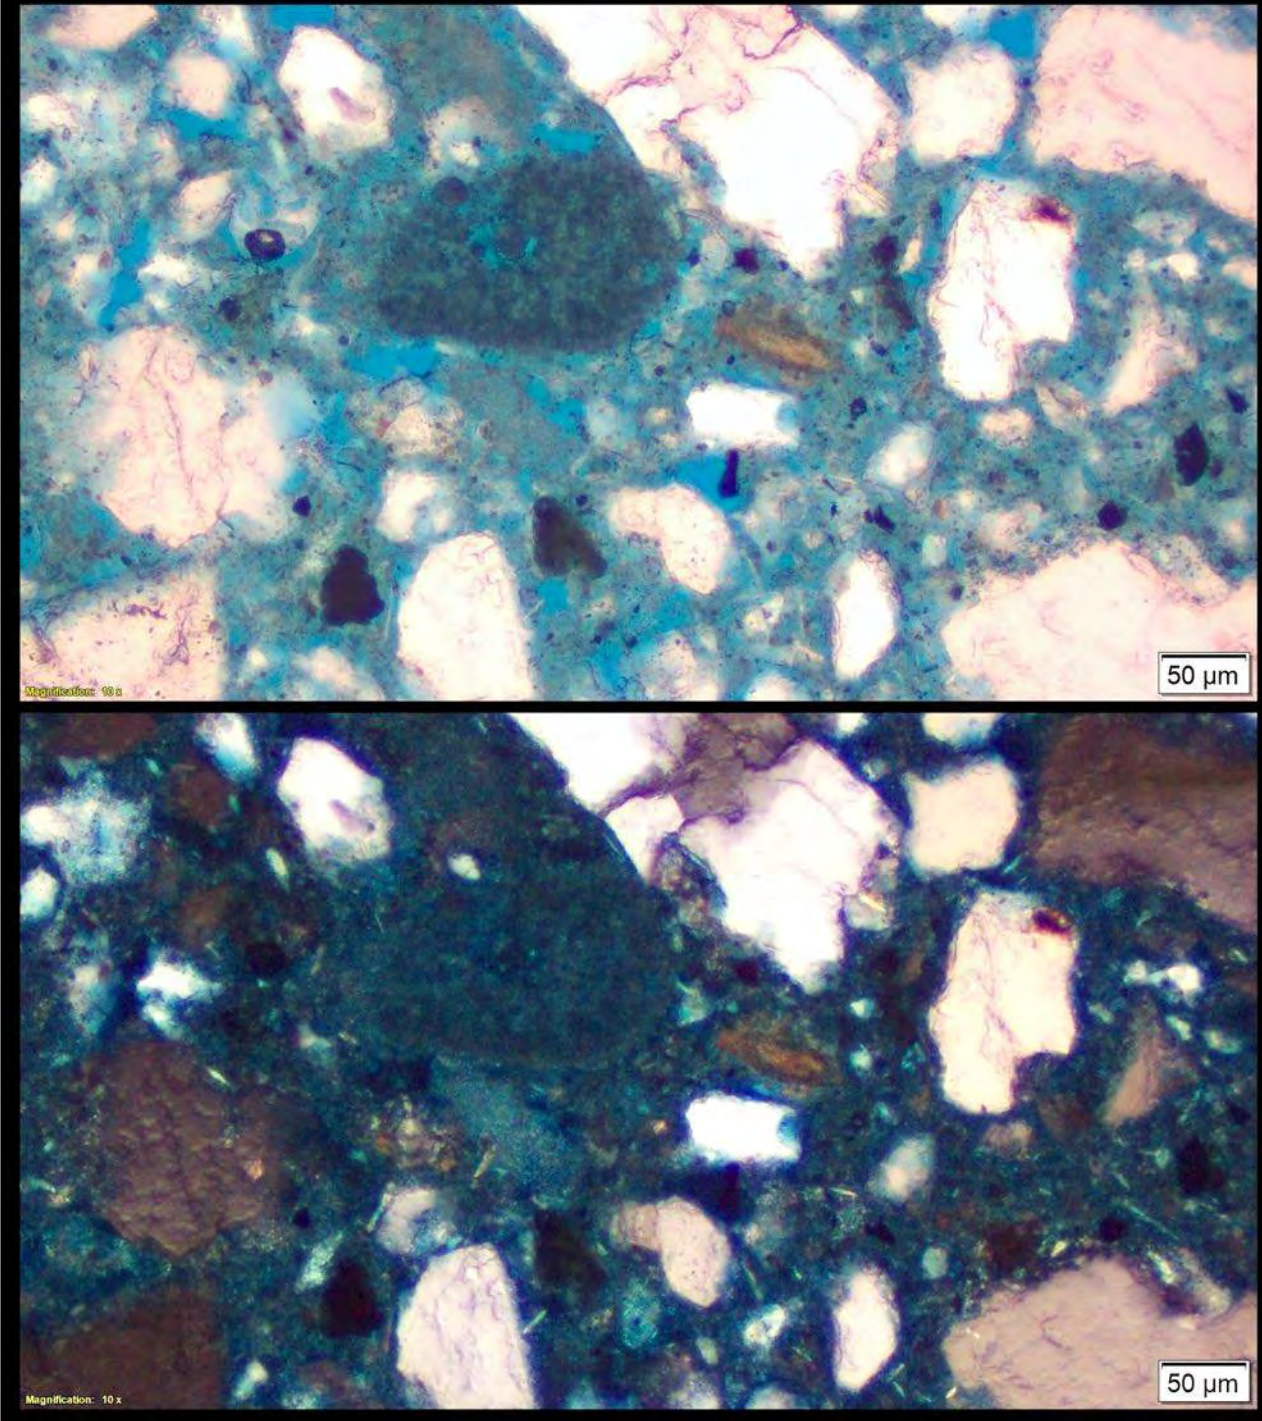
Figure 12: Micrographs of thin section of mortar showing: (a) very fine-grained, porous, carbonated to near-isotropic appearance of interstitial paste fraction; (b) subangular to subrounded, mostly equidimensional siliceous sand particles that are <1 mm in size, (c) some sheet-like flakes of mica and potential clay minerals, (d) a few lumps of unmixed lime that also shows a near-isotropic nature in XPL photo (bottom) as opposed to severely carbonated nature commonly found in lime lumps in many historic mortars, and (e) the non-air-entrained nature of mortar.

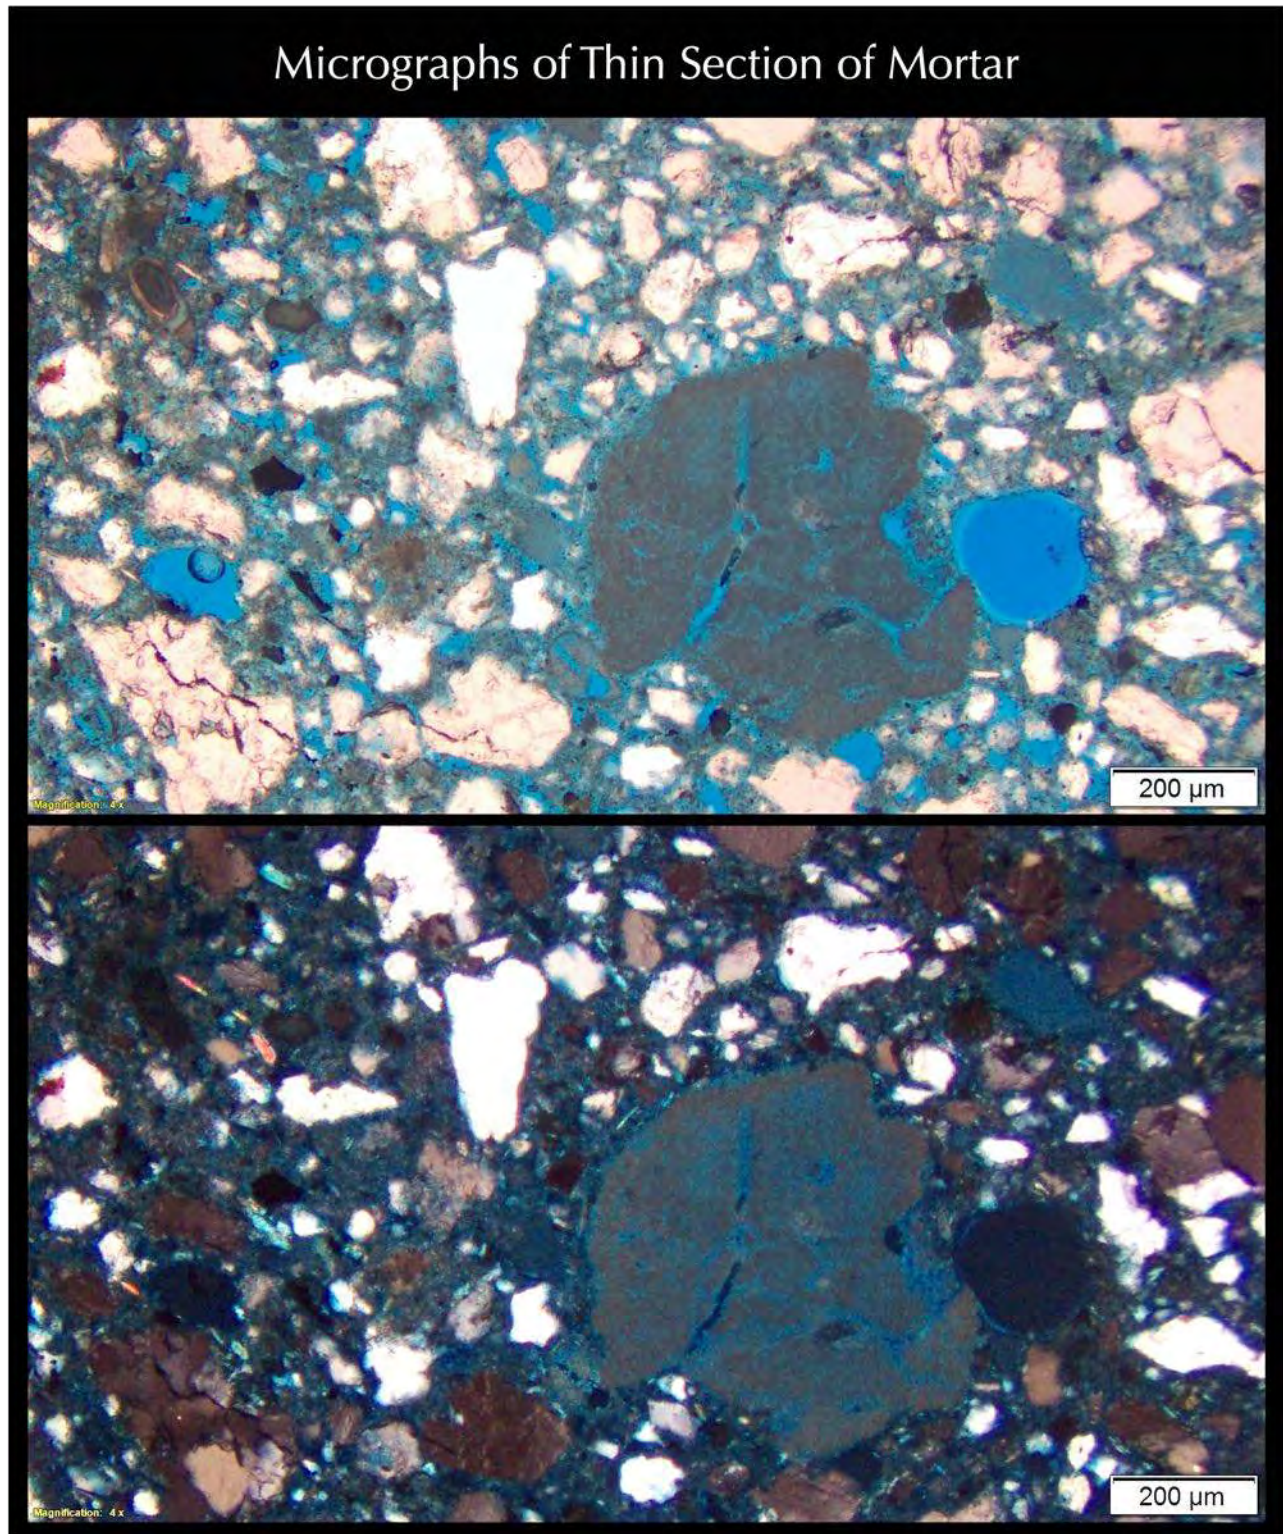
Figure 14: Micrographs of thin section of mortar showing: (a) very fine-grained, porous, carbonated to near-isotropic appearance of interstitial paste fraction; (b) subangular to subrounded, mostly equidimensional siliceous sand particles that are <1 mm in size, (c) some sheet-like flakes of mica and potential clay minerals, (d) a lump of unmixed lime at center, which shows characteristic shrinkage microcracks, and, a near-isotropic nature in XPL photo (bottom) as opposed to severely carbonated nature commonly found in lime lumps in many historic mortars, and (e) the non-air-entrained nature of mortar.

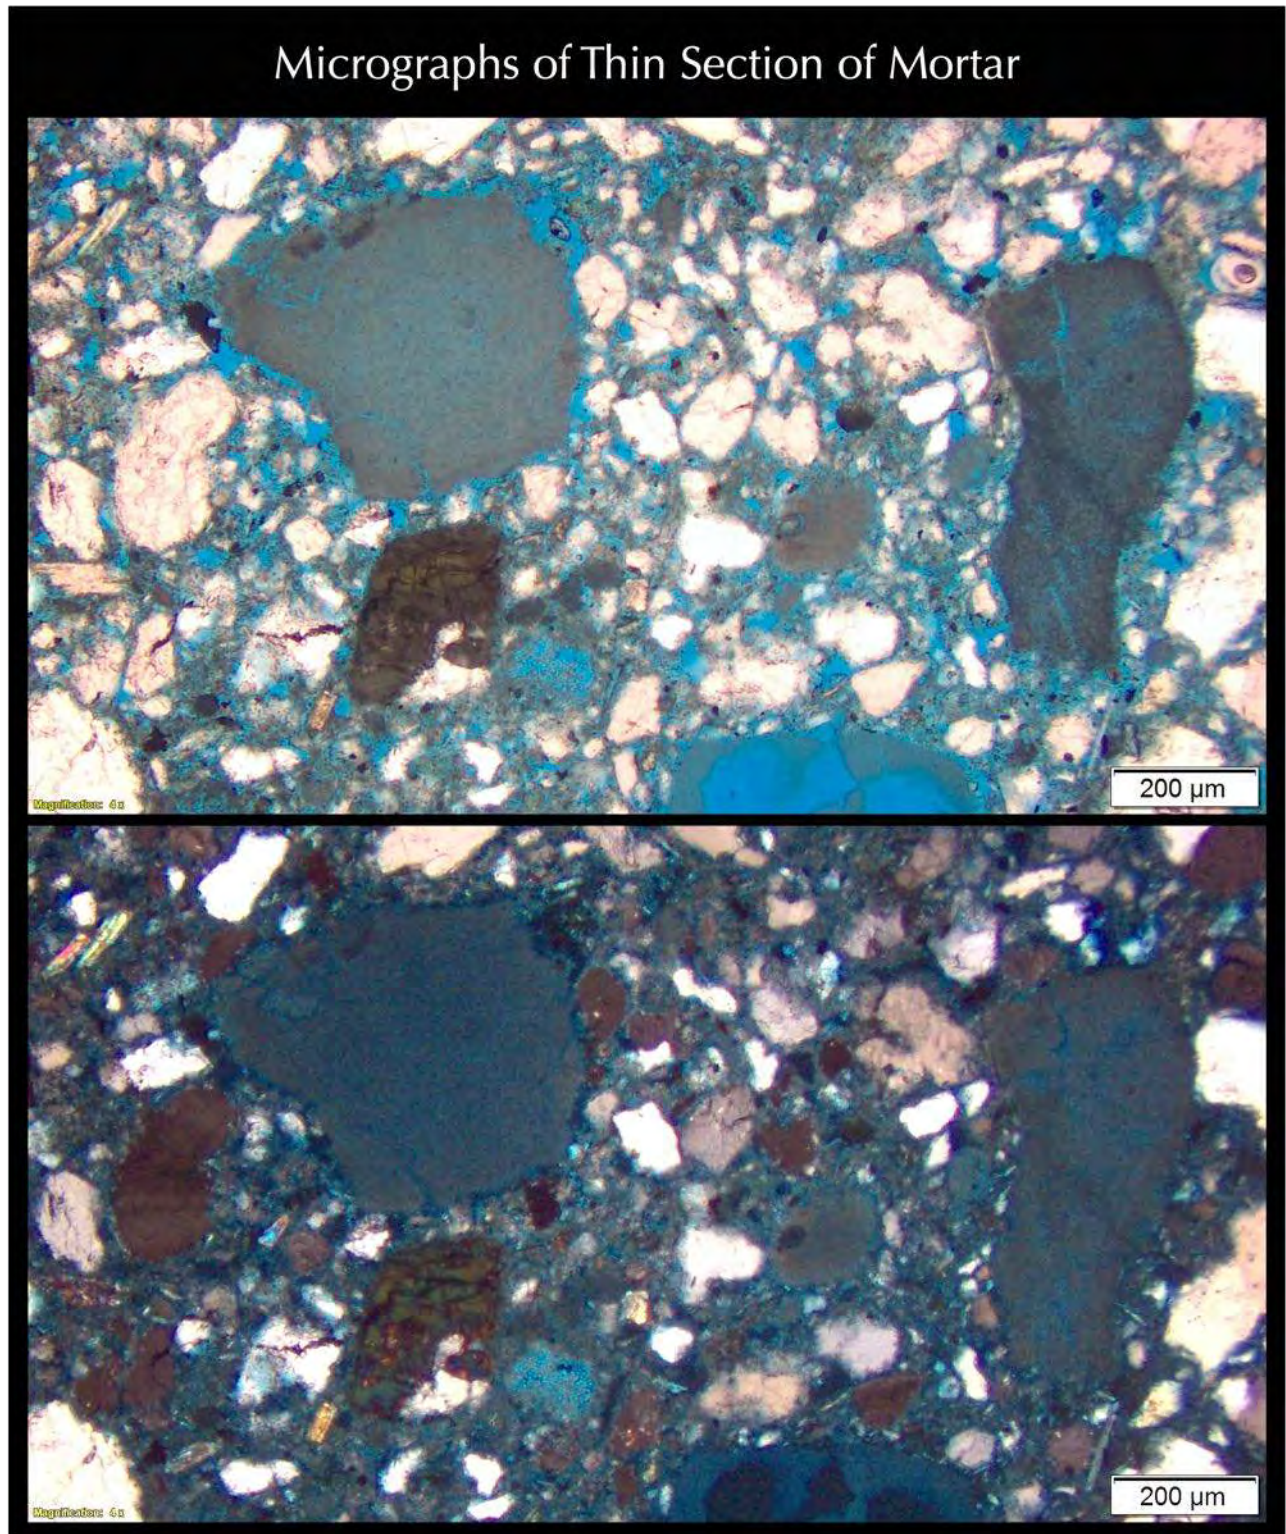
Figure 15: Micrographs of thin section of mortar showing: (a) very fine-grained, porous, carbonated to near-isotropic appearance of interstitial paste fraction; (b) subangular to subrounded, mostly equidimensional siliceous sand particles that are <1 mm in size, (c) some sheet-like flakes of mica and potential clay minerals, (d) a few lumps of unmixed lime, which also shows a near-isotropic nature in XPL photo (bottom) as opposed to severely carbonated nature commonly found in lime lumps in many historic mortars, and (e) the non-air-entrained nature of mortar.

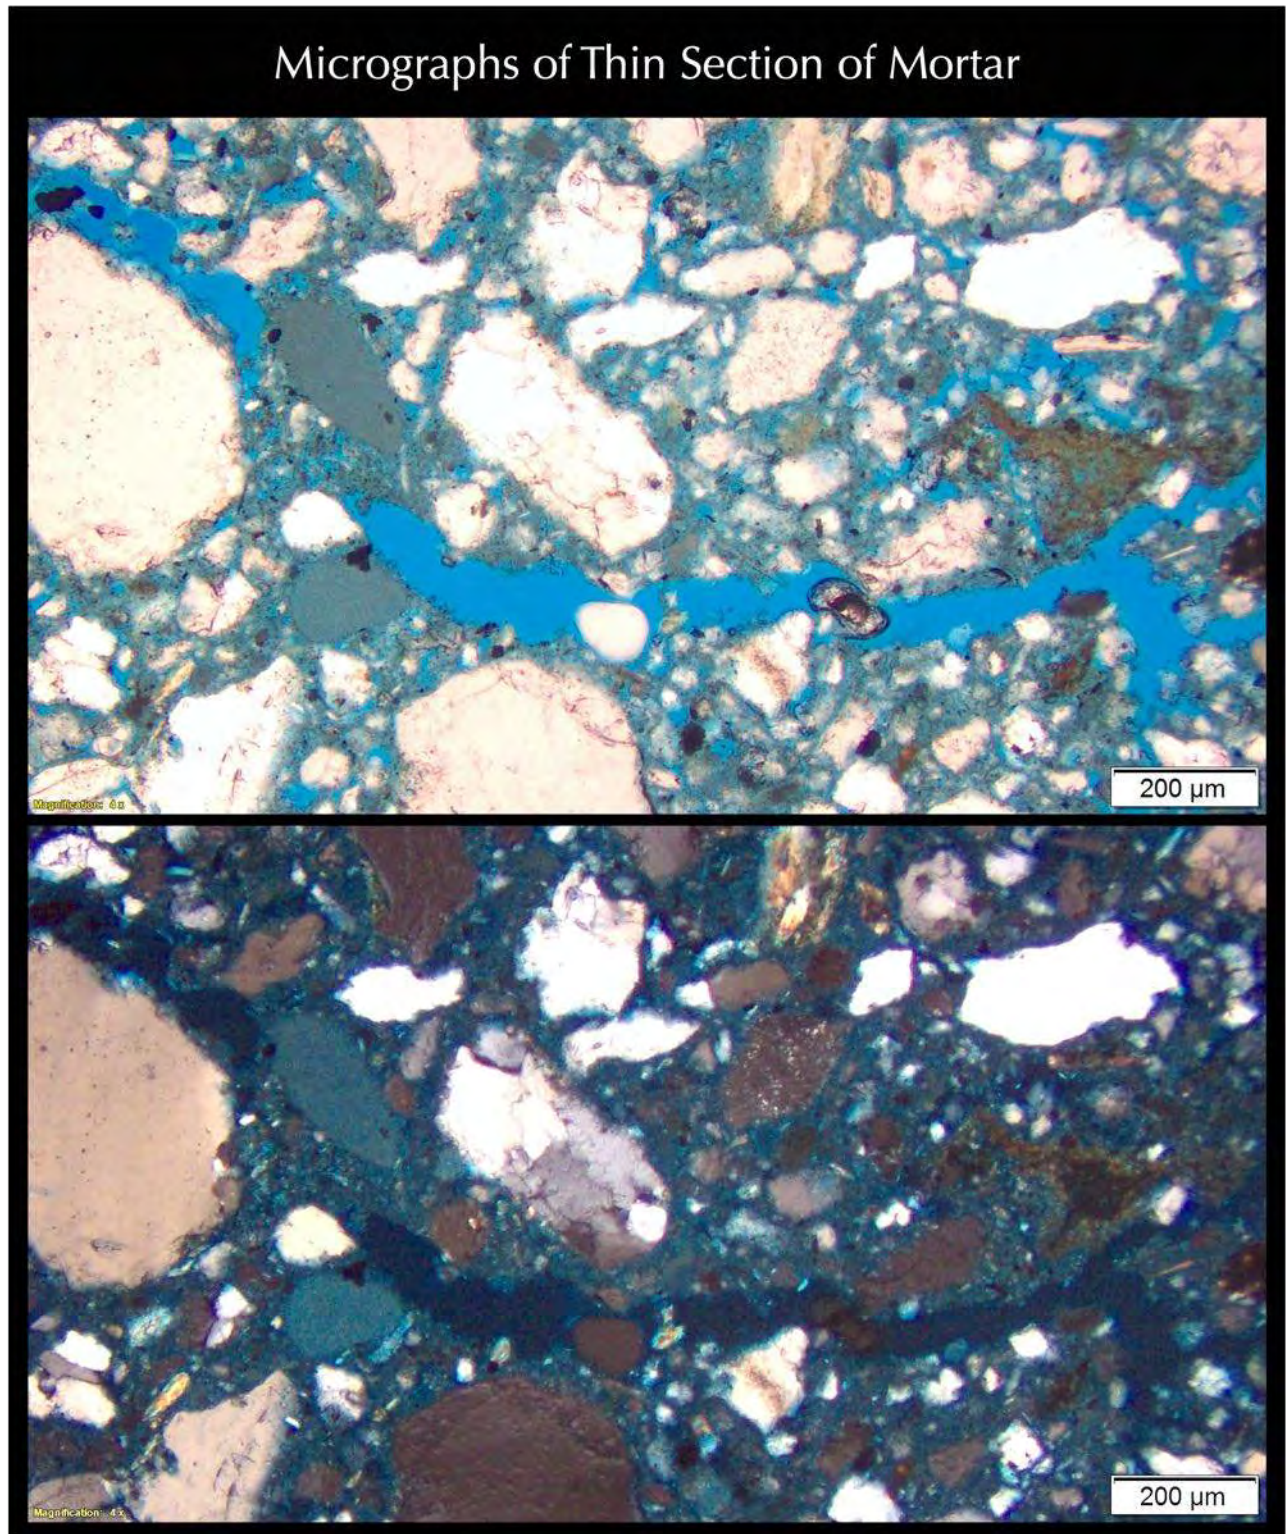
Figure 16: Micrographs of thin section of mortar showing: (a) very fine-grained, porous, carbonated to near-isotropic appearance of interstitial paste fraction; (b) subangular to subrounded, mostly equidimensional siliceous sand particles that are <1 mm in size, (c) some sheet-like flakes of mica and potential clay minerals, (d) a few lumps of unmixed lime, which also shows a near-isotropic nature in XPL photo (bottom) as opposed to severely carbonated nature commonly found in lime lumps in many historic mortars, and (e) the non-air-entrained nature of mortar. A reddish brown ferruginous silicified wood contaminant is seen at the left and center. A few porous areas and microcracks are highlighted by blue epoxy in the top PPL photo.
