HISTORIC STRUCTURE REPORT
FLUVANNA COUNTY HISTORIC COURTHOUSE
COUNTY OF FLUVANNA, VIRGINIA

HISTORIC STRUCTURE REPORT

FINAL REPORT

September 7, 2022

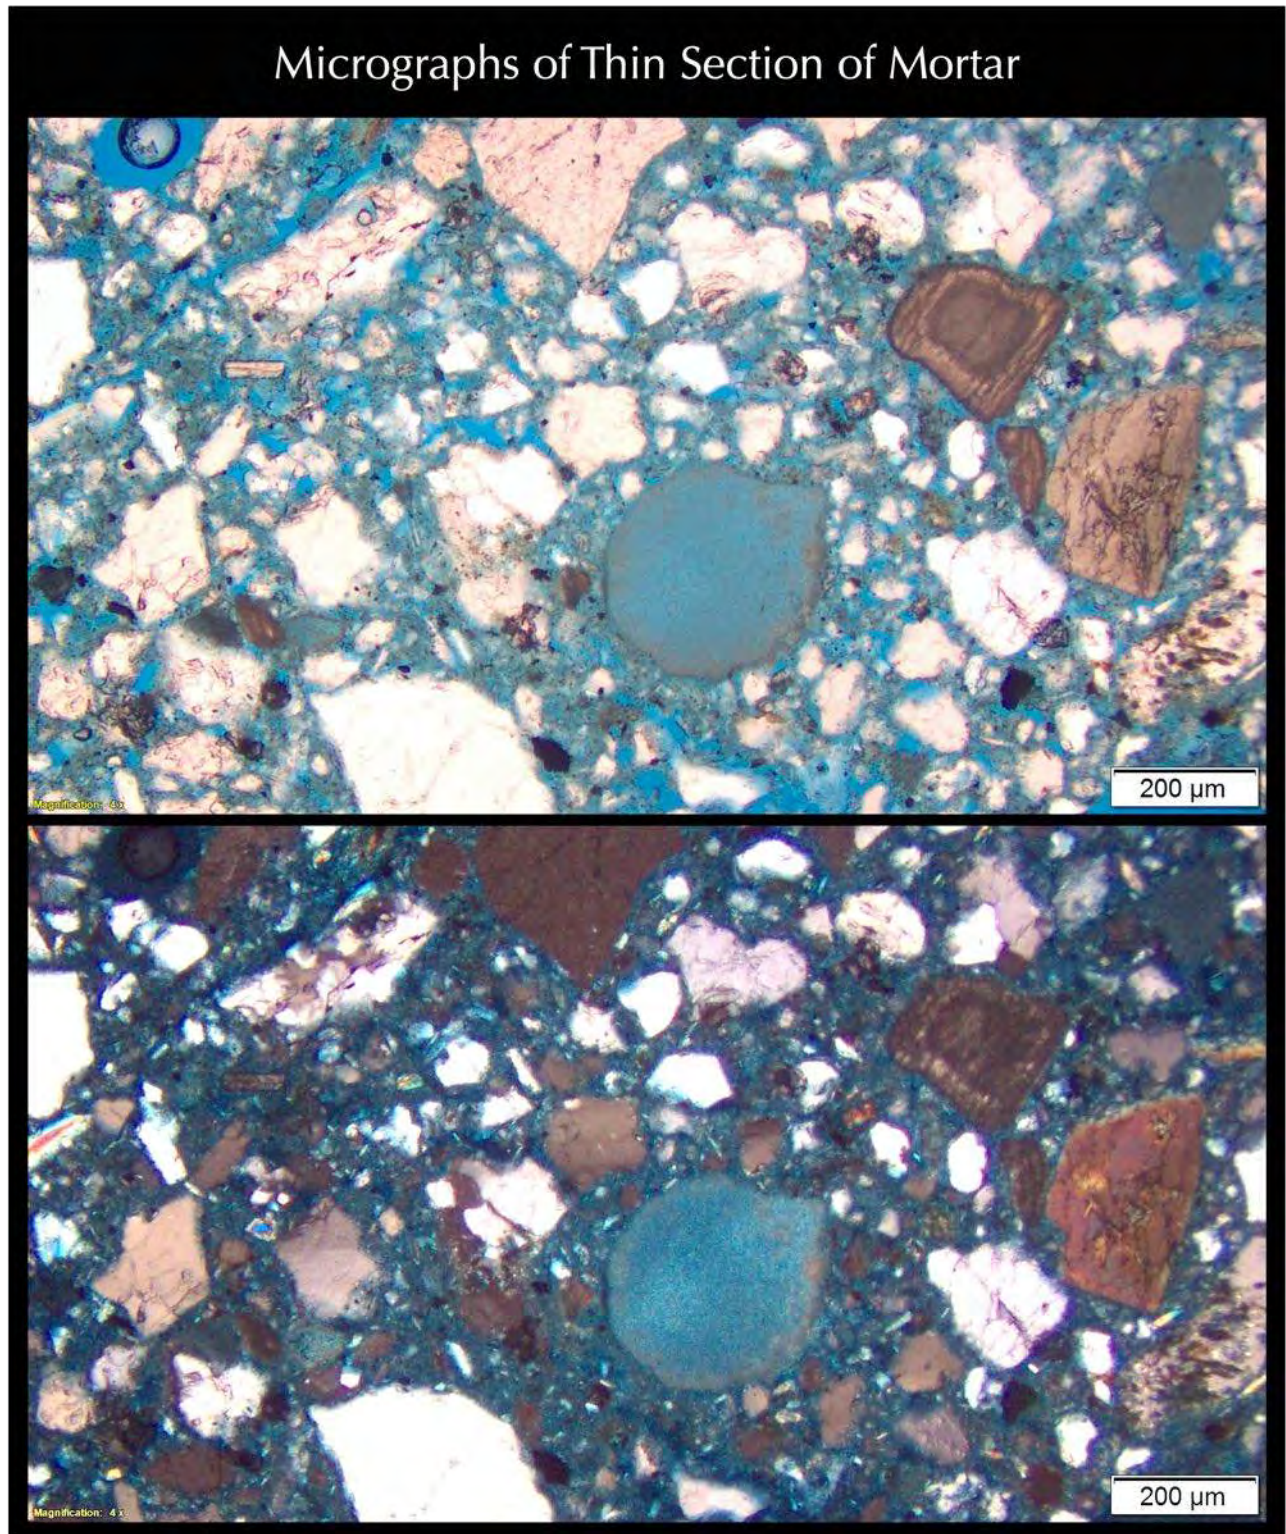
Figure 17: Micrographs of thin section of mortar showing: (a) very fine-grained, porous, carbonated to near-isotropic appearance of interstitial paste fraction; (b) subangular to subrounded, mostly equidimensional siliceous sand particles that are <1 mm in size, (c) some sheet-like flakes of mica and potential clay minerals, (d) a few lumps of unmixed lime, which also shows a near-isotropic nature in XPL photo (bottom) as opposed to severely carbonated nature commonly found in lime lumps in many historic mortars, and (e) the non-air-entrained nature of mortar. A microcrack is highlighted by blue epoxy in the top PPL photo.

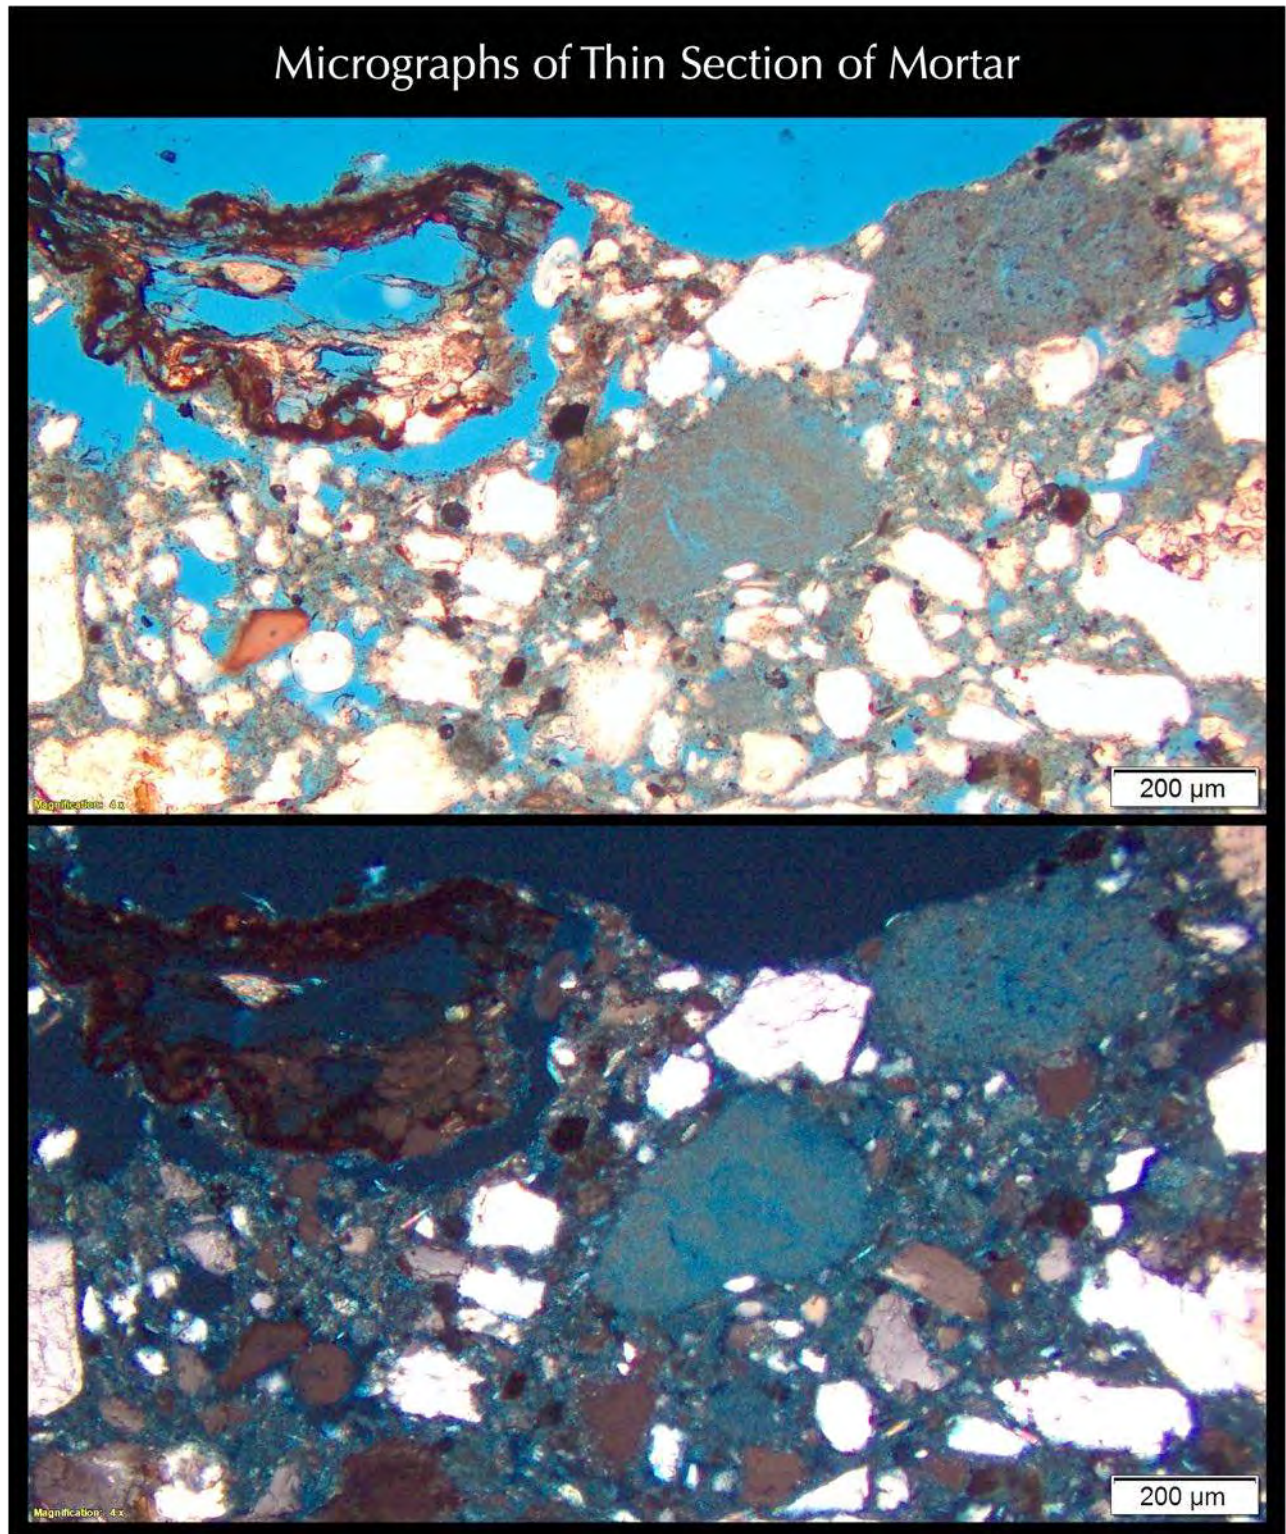
Figure 19: Micrographs of thin section of mortar showing: (a) very fine-grained, porous, carbonated to near-isotropic appearance of interstitial paste fraction; (b) subangular to subrounded, mostly equidimensional siliceous sand particles that are <1 mm in size, (c) some sheet-like flakes of mica and potential clay minerals, (d) a few lumps of unmixed lime, which also shows a near-isotropic nature in XPL photo (bottom) as opposed to severely carbonated nature commonly found in lime lumps in many historic mortars, and (e) the non-air-entrained nature of mortar. A reddish brown ferruginous silicified wood contaminant is seen at right.

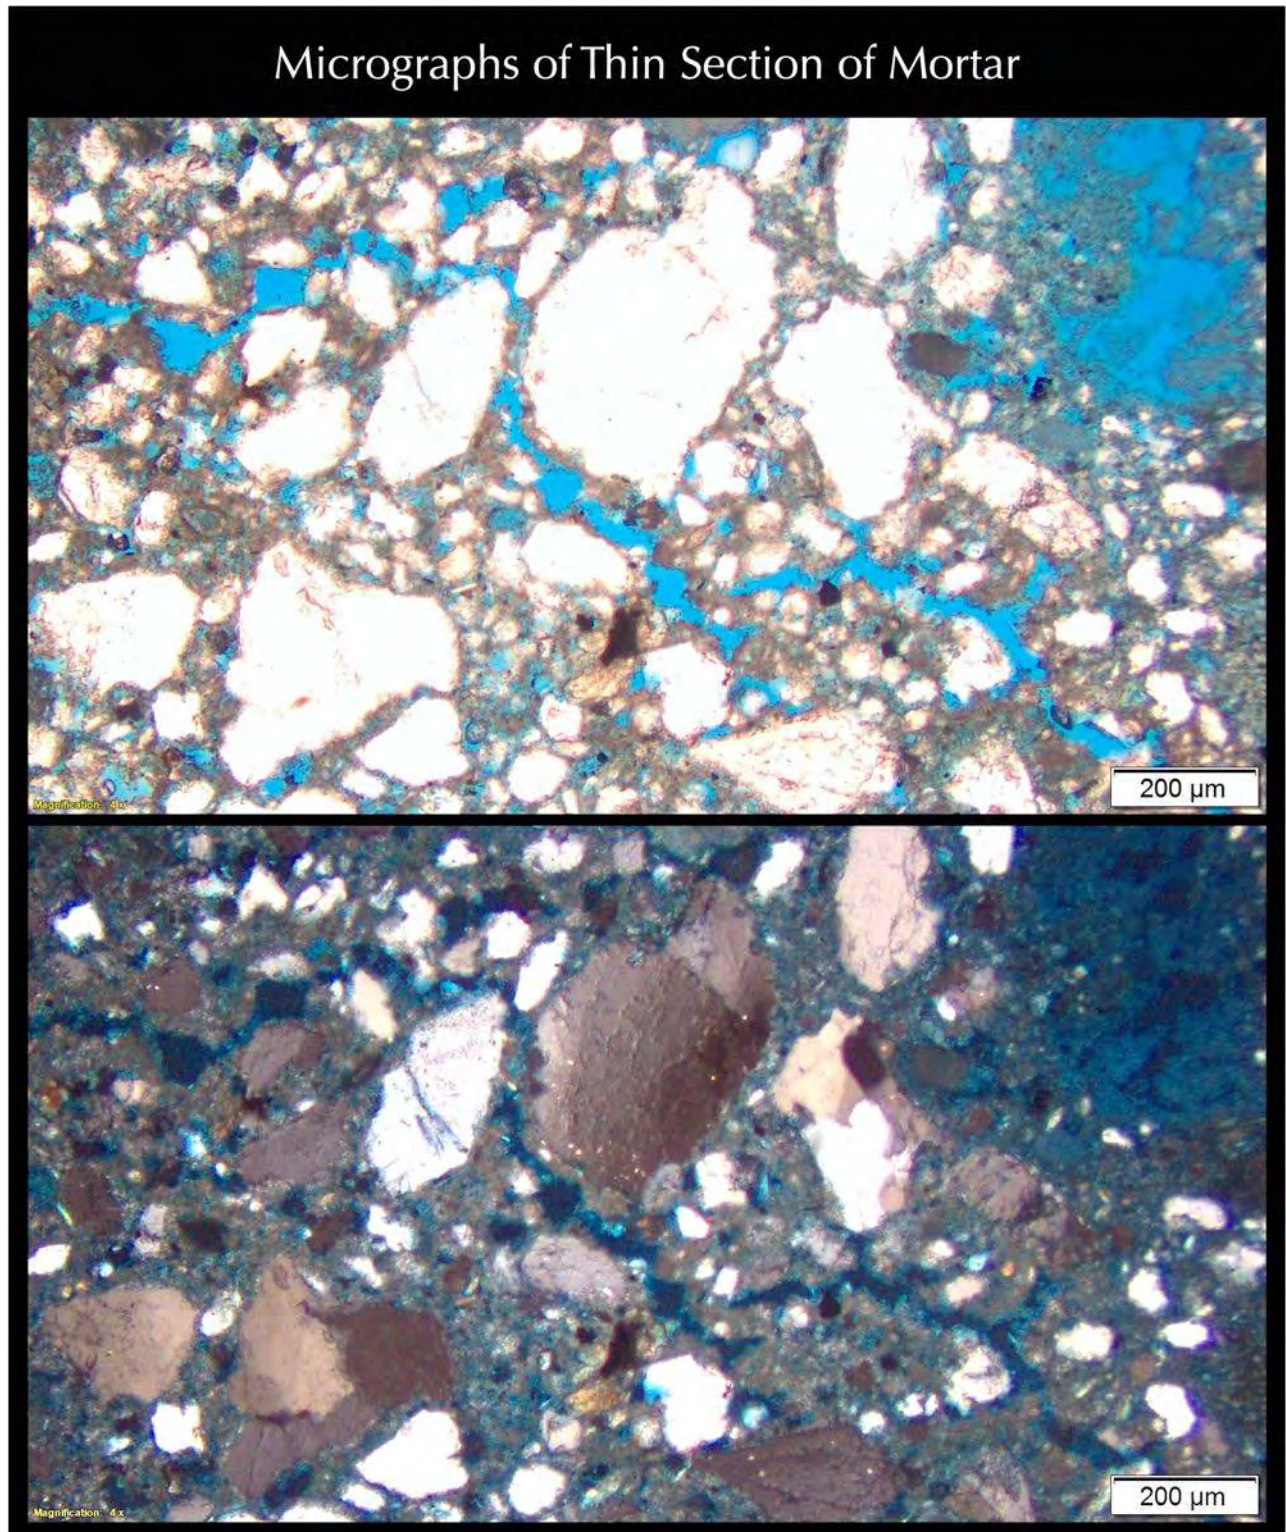
Figure 20: Micrographs of thin section of mortar showing: (a) very fine-grained, porous, carbonated to near-isotropic appearance of interstitial paste fraction; (b) subangular to subrounded, mostly equidimensional siliceous sand particles that are <1 mm in size, (c) some sheet-like flakes of mica and potential clay minerals, (d) a few lumps of unmixed lime, which also shows a near-isotropic nature in XPL photo (bottom) as opposed to severely carbonated nature commonly found in lime lumps in many historic mortars, and (e) the non-air-entrained nature of mortar. A reddish brown ferruginous silicified wood contaminant is seen at top.

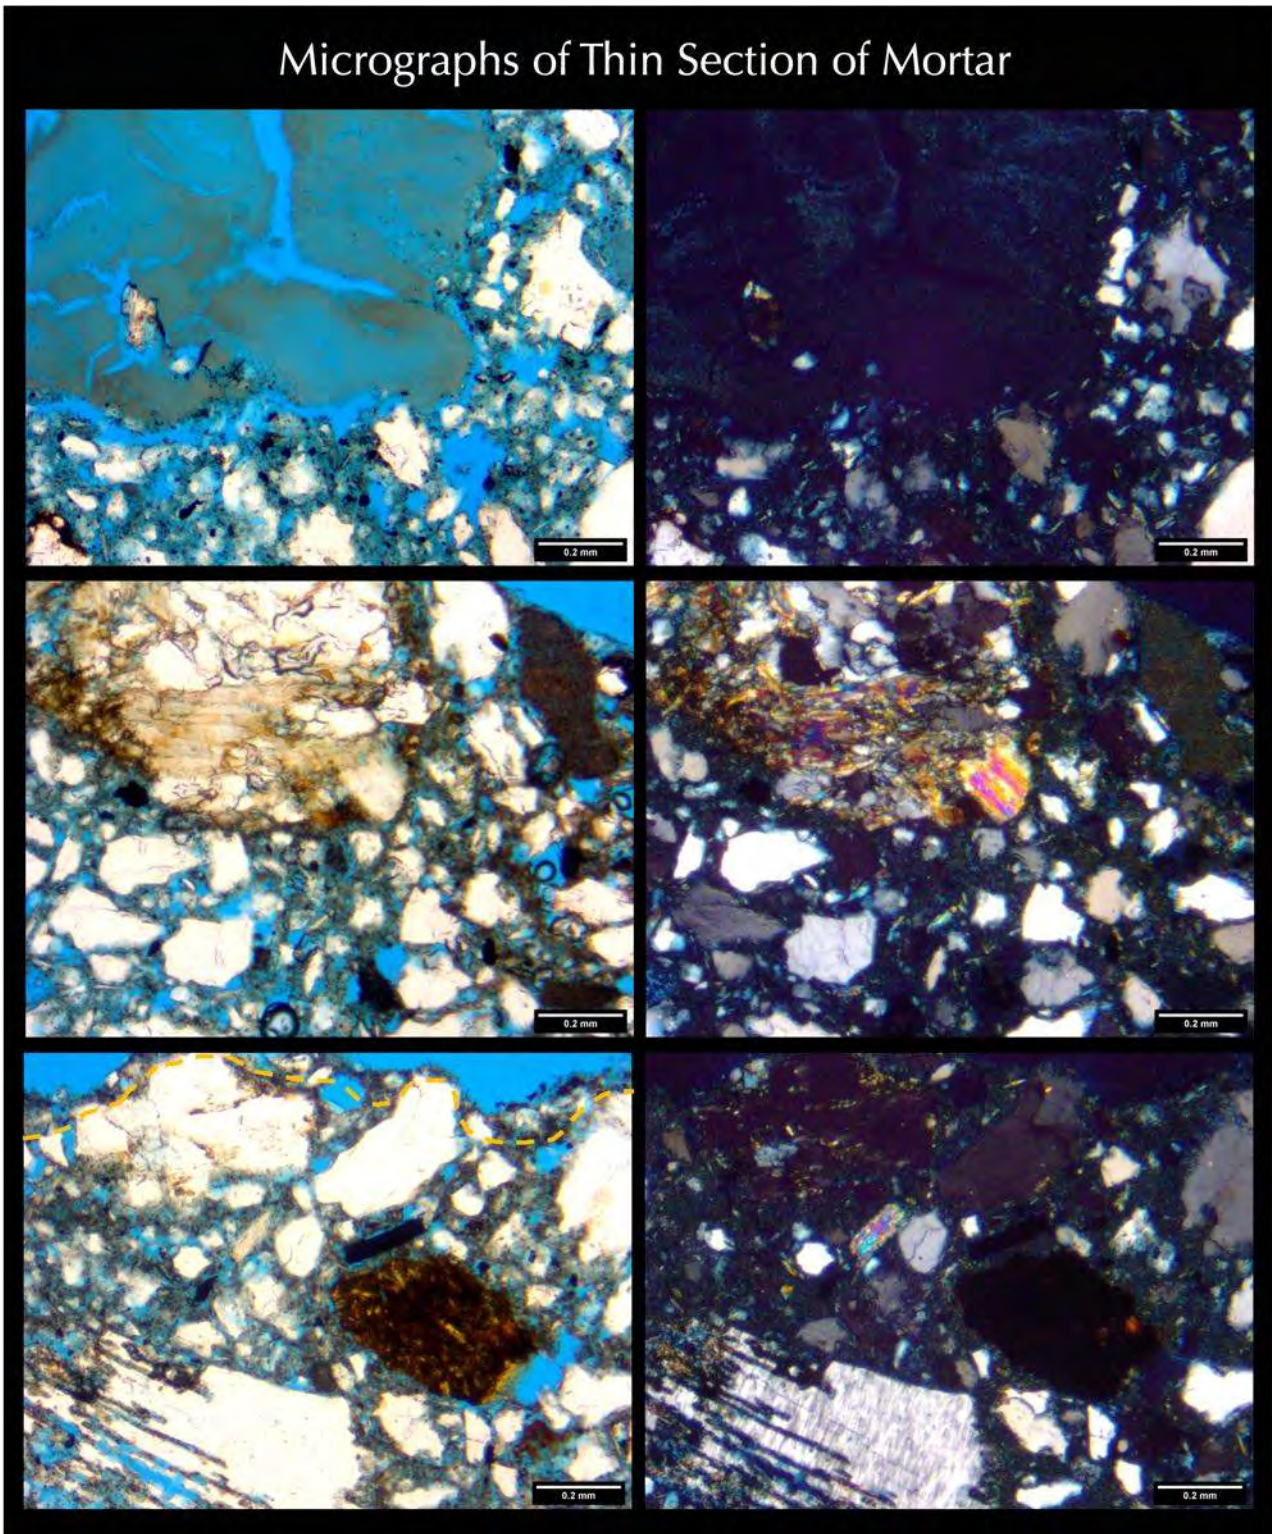
Figure 21: Micrographs of thin section of mortar showing: (a) very fine-grained, porous, carbonated to near-isotropic appearance of interstitial paste fraction; (b) subangular to subrounded, mostly equidimensional siliceous sand particles that are <1 mm in size, (c) some sheet-like flakes of mica and potential clay minerals, (d) a few lumps of unmixed lime, which also shows a near-isotropic nature in XPL photo (bottom) as opposed to severely carbonated nature commonly found in lime lumps in many historic mortars, and (e) the non-air-entrained nature of mortar. A few microcracks are highlighted by blue epoxy in the top PPL photo.

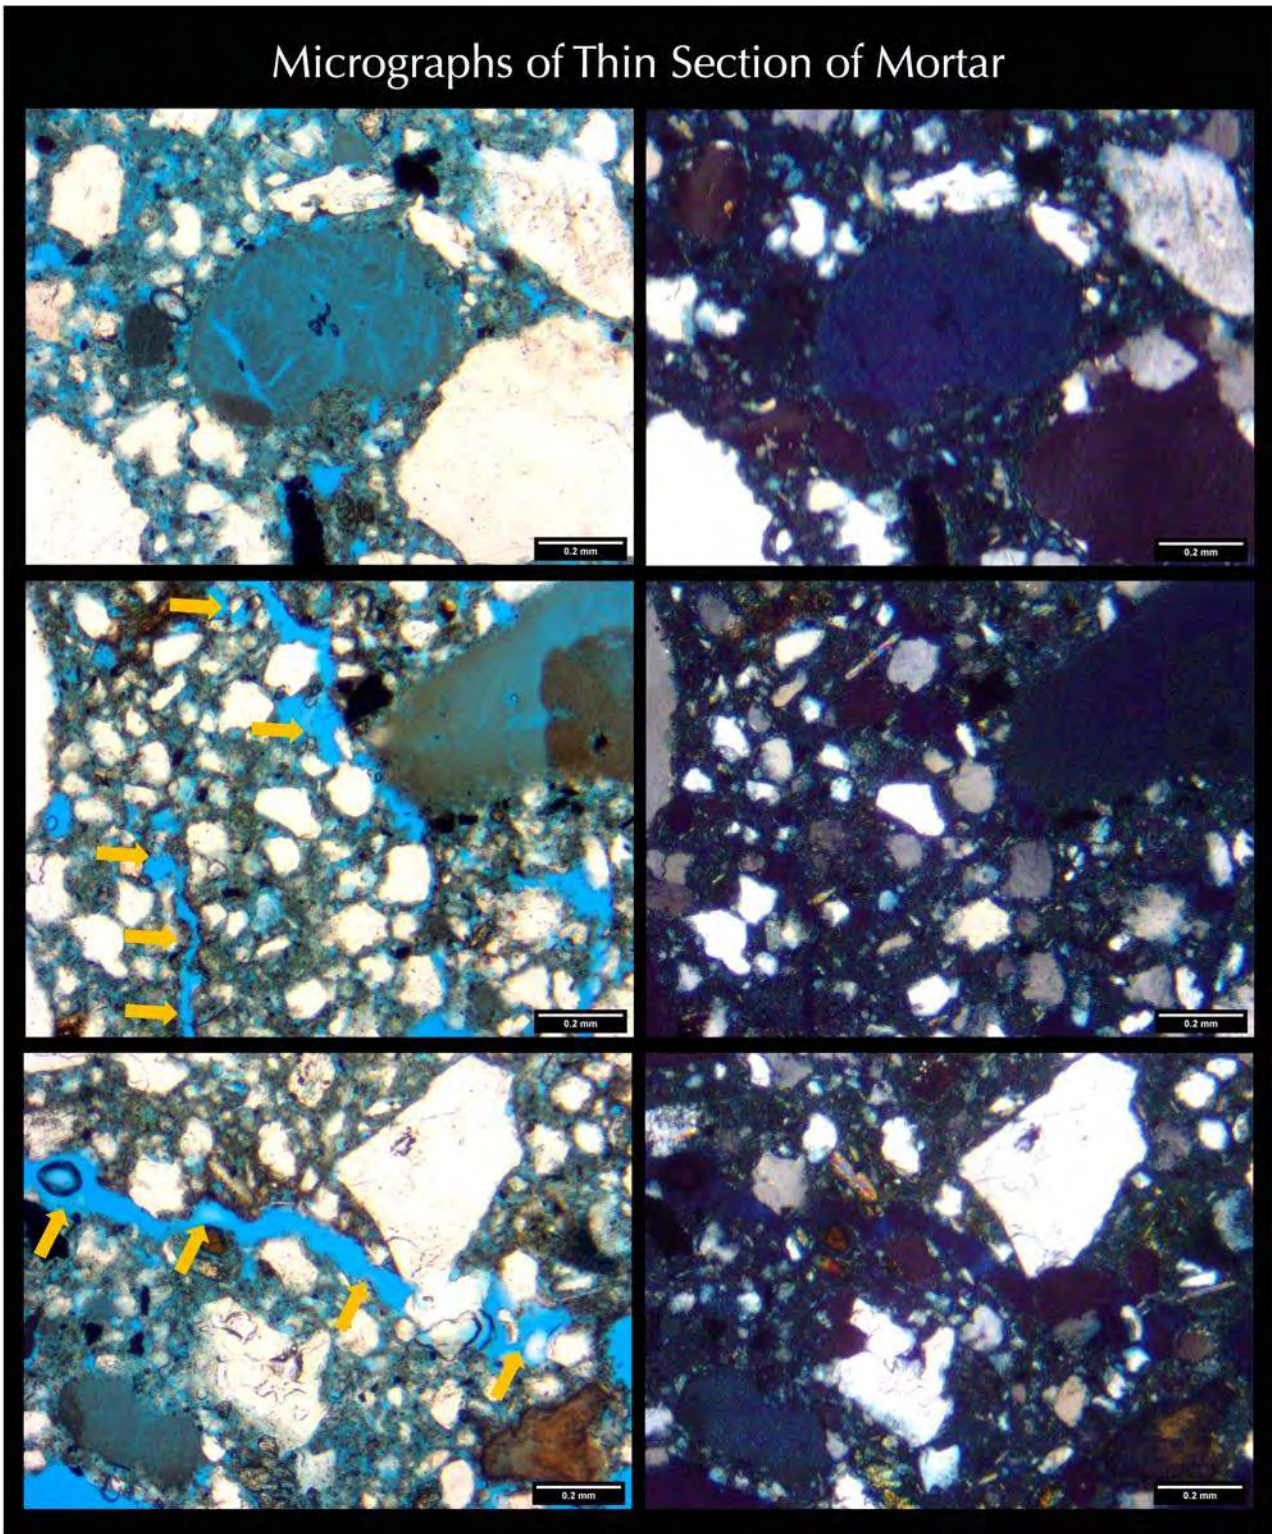
Figure 23: Micrographs of thin section of mortar showing: (a) very fine-grained, porous, mildly carbonated to near-isotropic appearance of interstitial paste fraction; (b) subangular to subrounded, mostly equidimensional siliceous sand particles that are <1 mm in size, (c) some sheet-like flakes of mica and potential clay minerals, (d) a few lumps of unmixed lime, which also shows a near-isotropic nature in XPL photo (bottom) as opposed to severely carbonated nature commonly found in lime lumps in many historic mortars, and (e) the non-air-entrained nature of mortar. A few microcracks are highlighted by blue epoxy in the top left PPL photo. A ferruginous reddish brown contaminant is seen in the middle row photos.

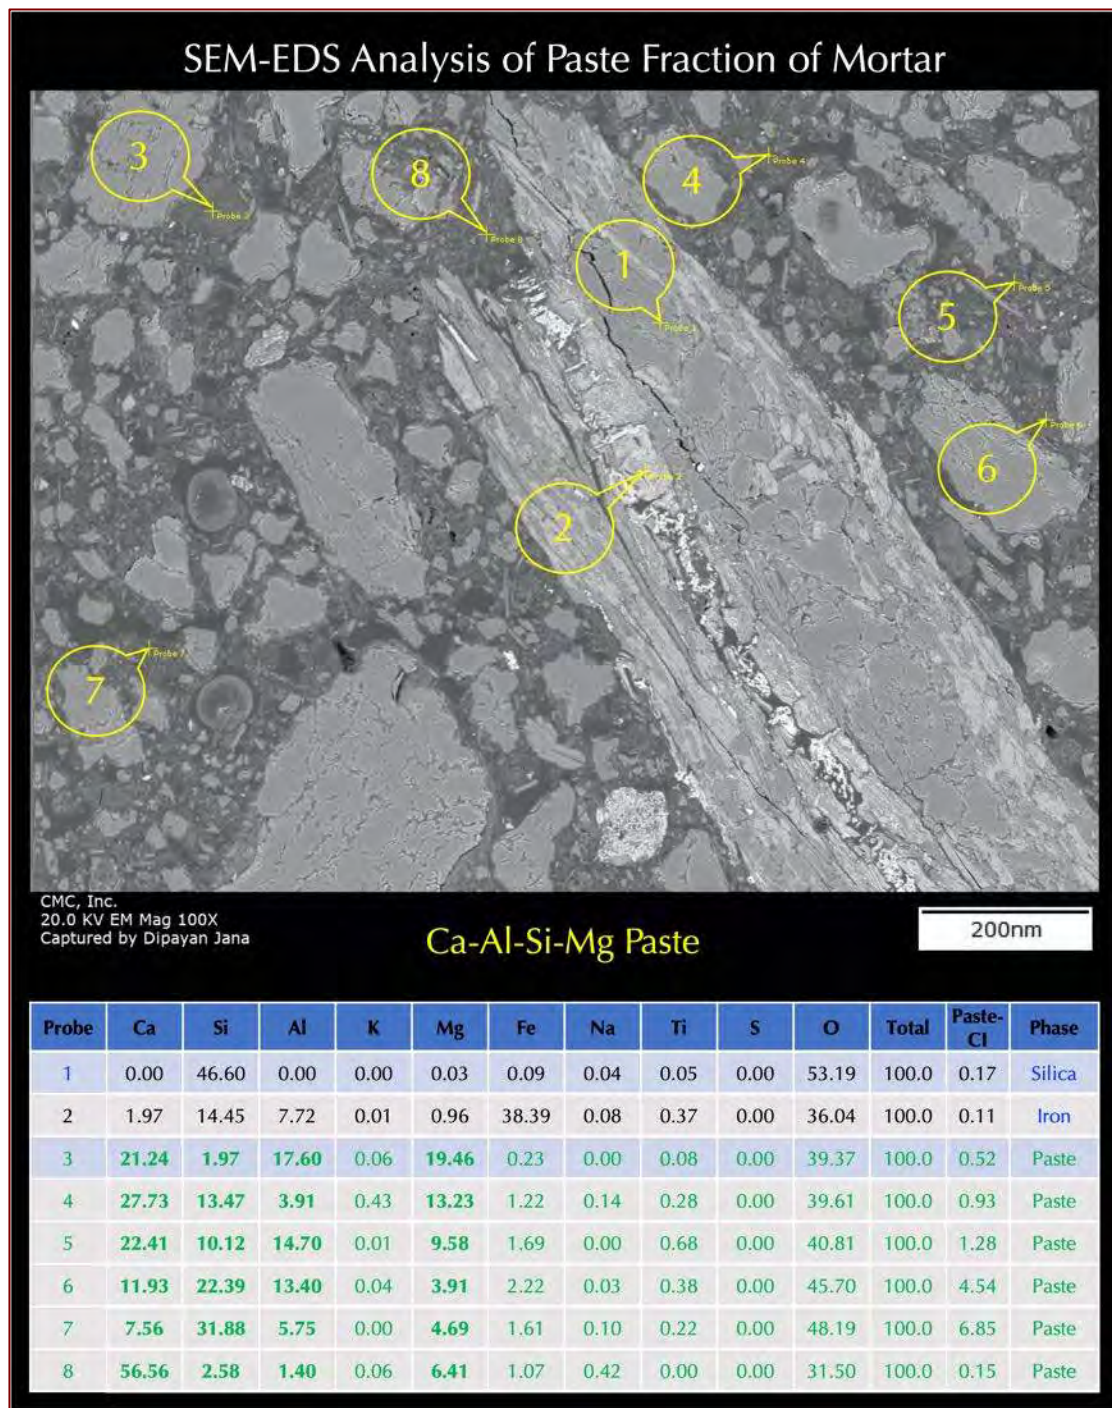
Figure 29: Backscatter electron image (top), and X-ray microanalyses at the tips of callouts in Probes 1 through 8 detecting compositional variations of paste and a contaminant in the mortar. Paste and contaminant compositions are presented (bottom) as oxide variations of all detected EDS peaks normalized to 100% except carbon (from epoxy) and gold (from coating). Paste cementation indices, CI (after Eckel 1922) measure relative hydraulicity of paste e.g., non-hydraulic lime pastes have very low CI (< 0.50) compared to Portland cement pastes (CI is >1). Paste shows mostly CI > 1 as opposed to typical <1 value for carbonated lime pastes in many historic mortars indicating the presence of silica and alumina from addition of calcined clay component as a second binder after lime. The cementation indices (CI) of paste are calculated after Eckel (1922) as $CI = [(2.8 \cdot SiO_2) + (1.1 \cdot Al_2O_3) + (0.7 \cdot Fe_2O_3)] / [(CaO) + (1.4 \cdot MgO)]$. The contaminant at the center shows silica and iron from ferruginous silicified composition as seen in optical micrographs.

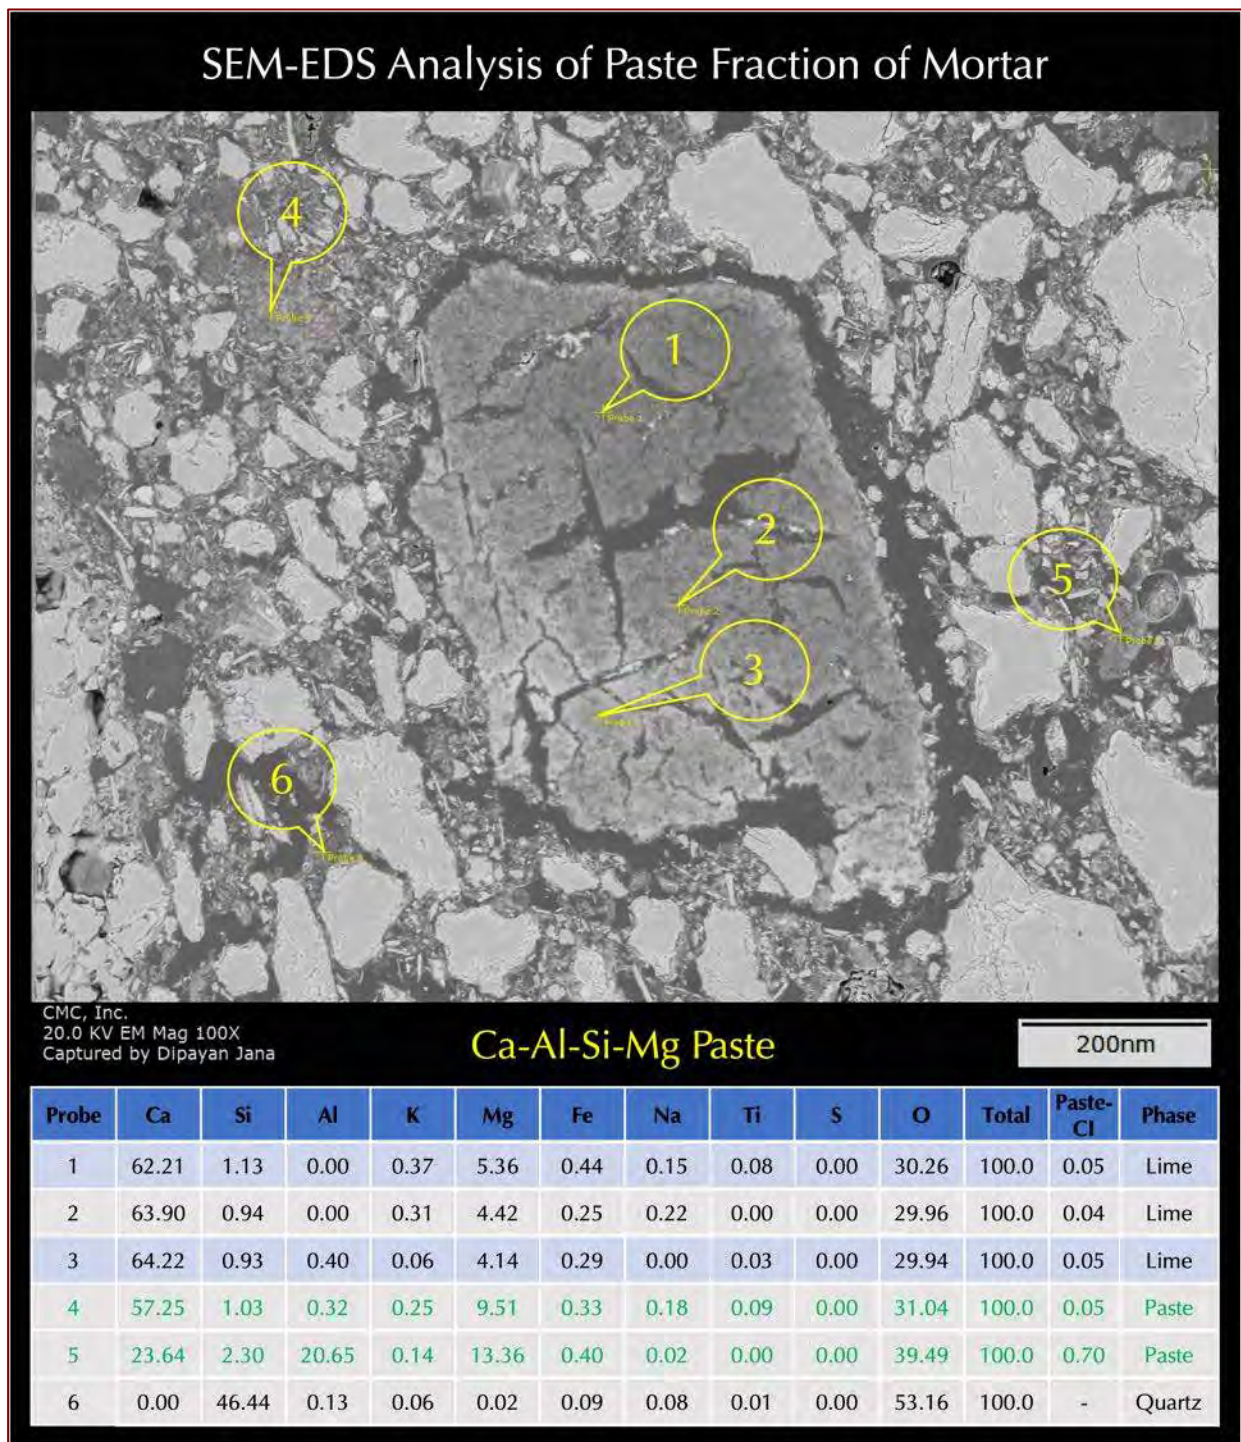
Figure 30: Backscatter electron image (top), and X-ray microanalyses at the tips of callouts in Probes 1 through 6 detecting compositional variations of a central incompletely burnt dolomitic lime and neighboring paste in the mortar. Compositions are presented (bottom) as oxide variations of all detected EDS peaks normalized to 100% except carbon (from epoxy) and gold (from coating). Paste cementation indices, CI (after Eckel 1922) measure relative hydraulicity of paste e.g., non-hydraulic lime pastes have very low CI (< 0.50) compared to Portland cement pastes (CI is >1). Both the central lime and neighboring paste show CI < 1. The cementation indices (CI) of paste are calculated after Eckel (1922) as $CI = [(2.8 \cdot SiO_2) + (1.1 \cdot Al_2O_3) + (0.7 \cdot Fe_2O_3)] / [(CaO) + (1.4 \cdot MgO)]$. Probe #6 is from a fine quartz sand particle.

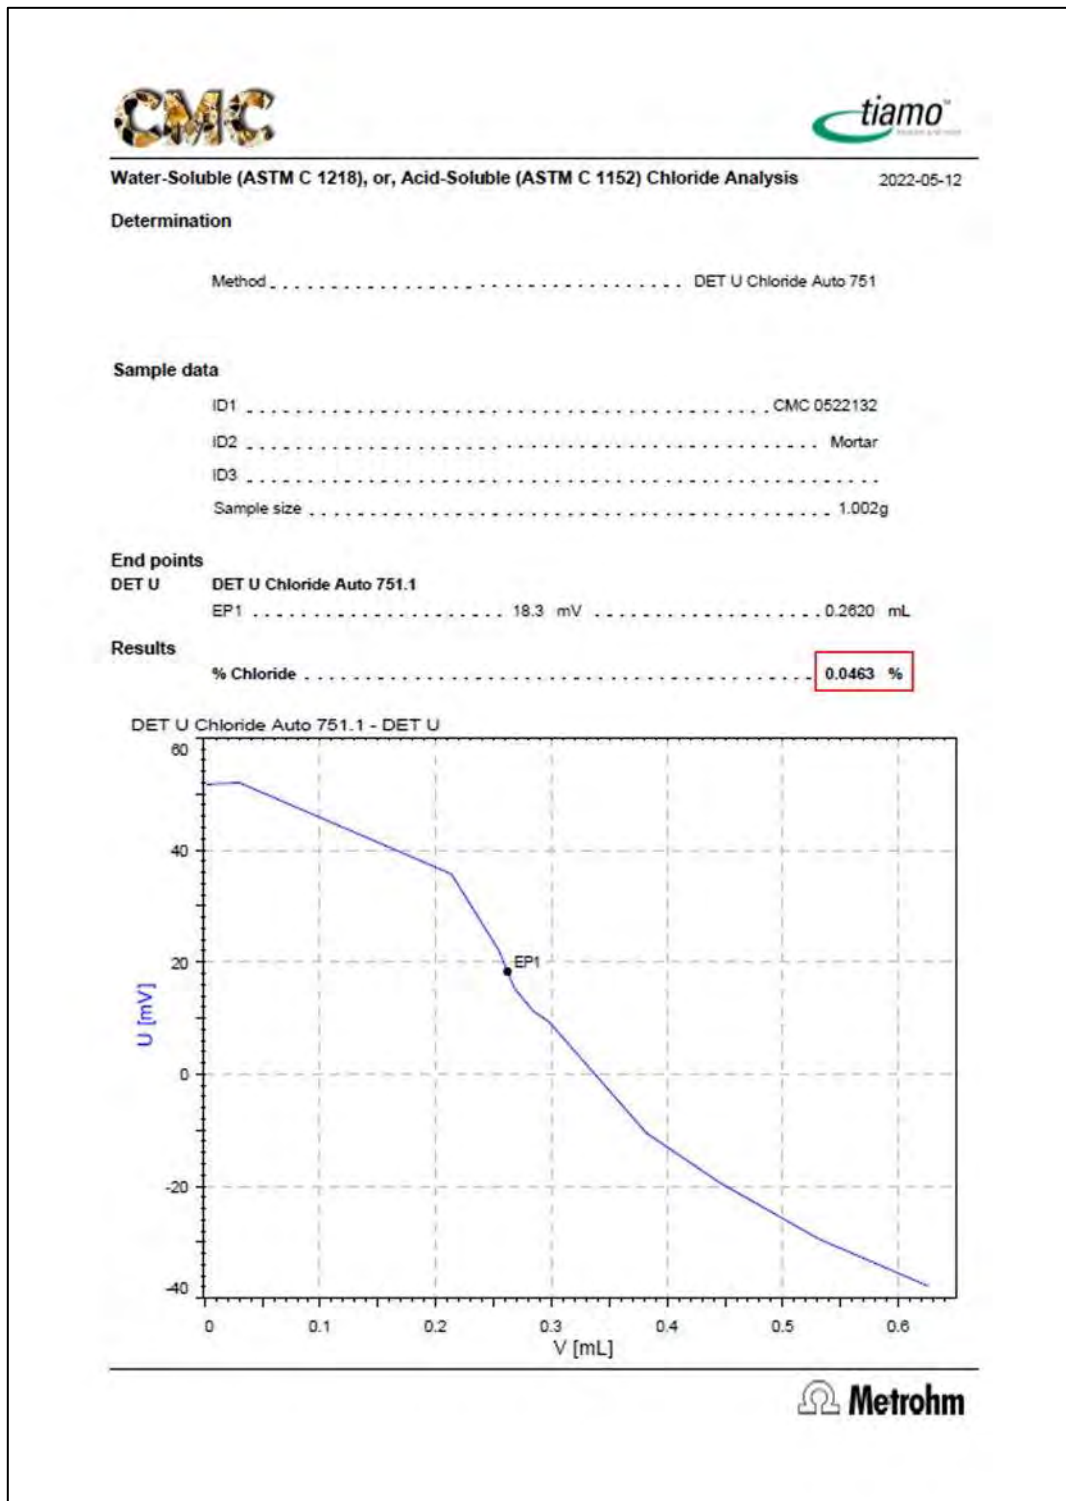
Figure 35: Water-soluble chloride in the mortar after digesting about a gram of pulverized mortar in deionized water for 30 minutes at a temperature below boiling, followed by continued digestion in water at the ambient laboratory condition for 24 hours. The filtrate was analyzed by potentiometric titration with a silver nitrate titrant. Filtrate shows the presence of negligible but detectable chloride.
